# A slope stability problem in Hong Kong

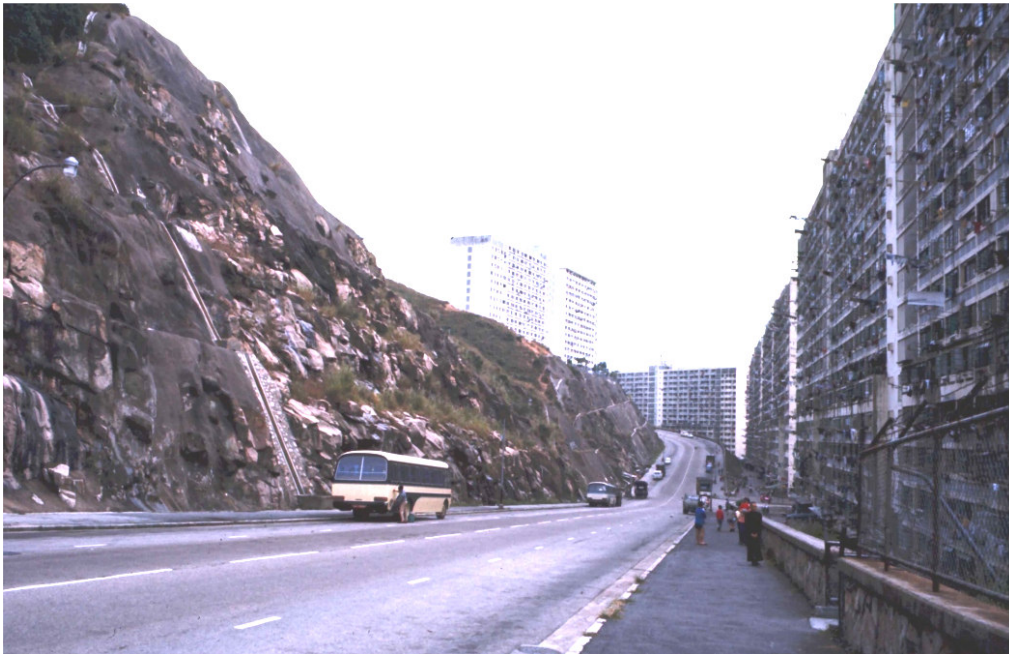
Figure 1 gives a general view down Sau Mau Ping Road, showing the steep rock slopes on the left and the apartment blocks on the right.

Figure 1: A view down Sau Mau Ping Road in Kowloon showing apartment blocks across the road from the steep rock slopes.

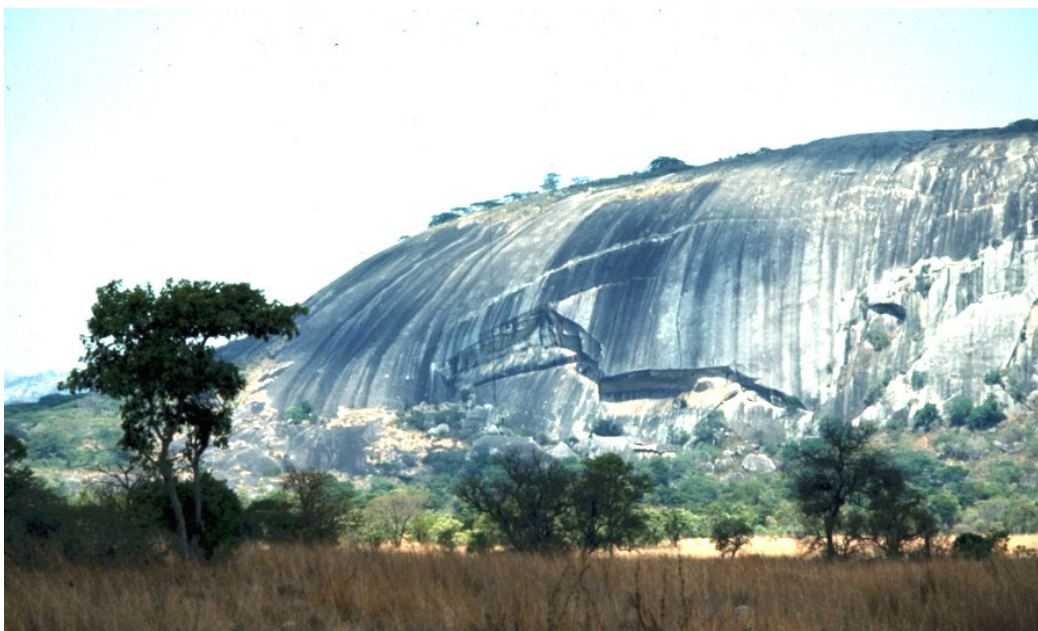
Figure 2: Sheet jointing in granite. These features, sometimes referred to as 'onion skin' joints, are the result of exfoliation processes during cooling of the granite.

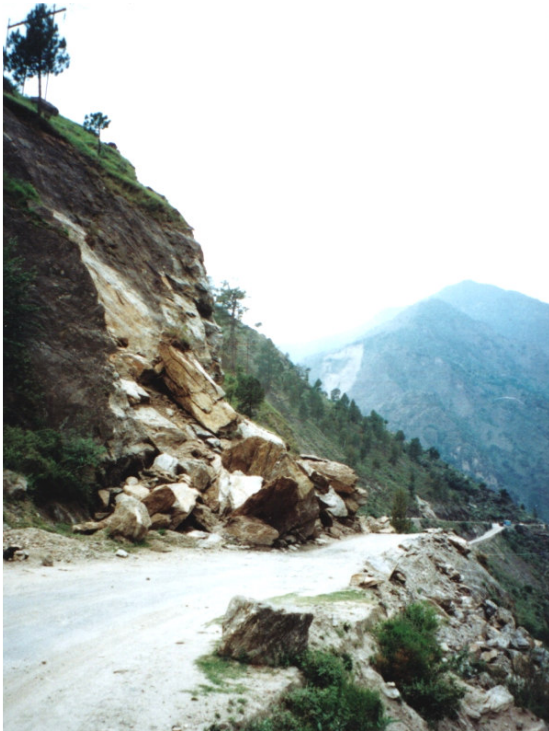
Figure 3: A rock slide on a road caused by the undercutting of sheet joints in a granite slope. In hard rocks such as granite, failure can occur very suddenly if the factor of safety of the slope is close to 1. A rise in groundwater levels during a heavy storm or ice jacking in winter may be sufficient to induce failure.

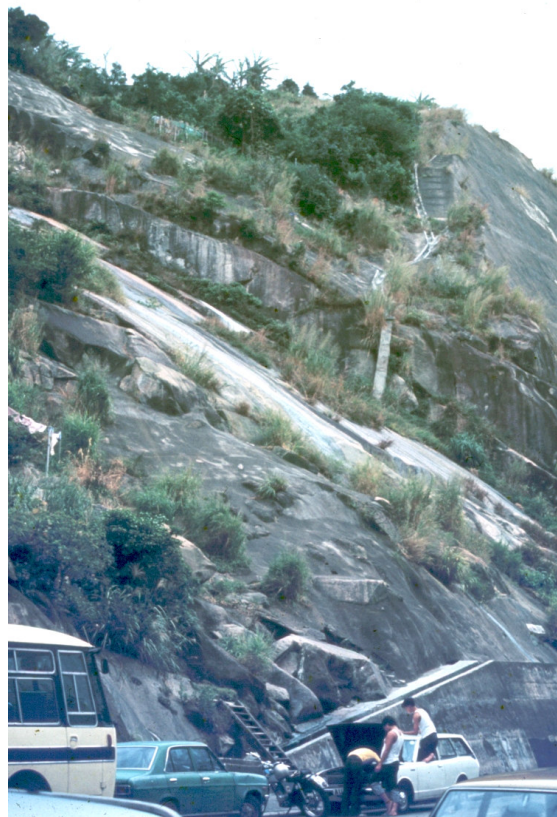
During excavation of the original slopes for the Sau Mau Ping Road, a small rock slide was induced by blasting. The surface on which this failure occurred is illustrated in Figure 4. Blasting, such as that used in civil construction in an urban environment, does not impose very large loads on rock slopes and it can be assumed that the factor of safety of the slope was close to unity.

Figure 4: The failure surface defined by a sheet joint surface on which a small slide occurred during blasting of the original cut slope for the Sau Mau Ping Road. The potentially unstable slope under consideration is visible in the background.

The potentially unstable slope under consideration is visible in the background of this photograph. It is obvious from this photograph that the sheet joint surface continues under the potentially unstable slope. Hence, from the evidence of the small scale failure, it can be deduced that the factor of safety of the slope in question is not very high.

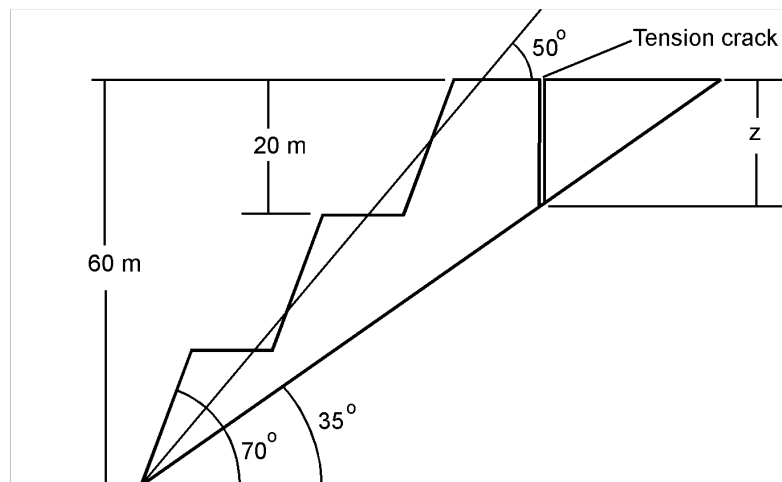
Figure 5: Geometry assumed for the two-dimensional analysis of the Sau Mau Ping Road slope.

The geometry of the slope is illustrated in Figure 5 which shows a 60 m high slope with three 20 m high benches. The overall slope angle is  $50^\circ$  and the individual bench faces are inclined at  $70^\circ$  to the horizontal. An exfoliation joint surface dips at  $35^\circ$  and undercuts the slope as shown in the figure. The slope face strikes parallel to the underlying exfoliation surface and hence the slope can be analysed by means of a two-dimensional model.

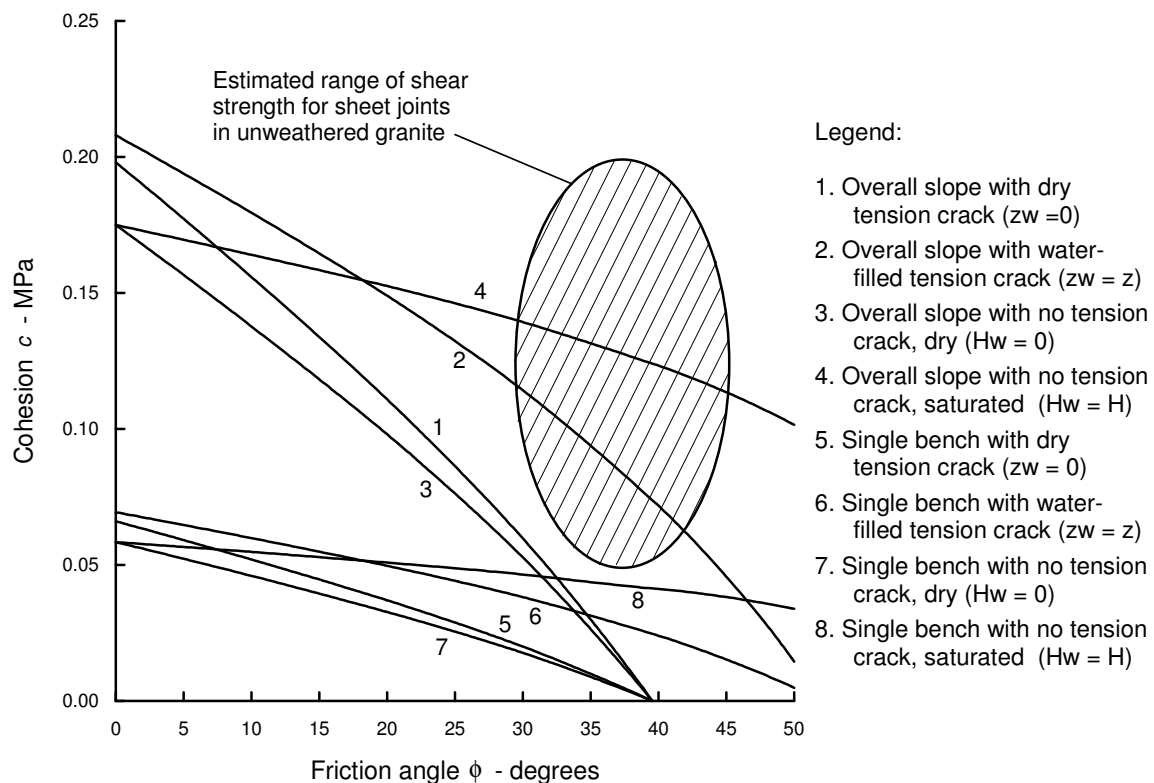
Figure 9: Comparison of the shear strength mobilised by failure under various conditions with the estimated shear strength available on sheet joints in unweathered granite.

Figure 9 shows that only two of the cases analysed result in conditions where the shear strength mobilised at failure falls within the estimated range of available shear strength. These two cases are designated 2 and 4 and they are for fully saturated slopes, with and without tension cracks.

From the results of the sensitivity study described above it was concluded that instability of this particular slope could occur if the slope was fully saturated and subjected to earthquake loading. Typhoons occur several times every year in Hong Kong and the intensity of precipitation during these events is certainly sufficient to saturate the slopes. As discussed earlier, minor earthquakes do occur in the region but they are not very frequent. Consequently, the chance of simultaneous saturation and earthquake loading was considered to be small and it was concluded that there was no serious short-term threat of instability of the Sau Mau Ping slope.

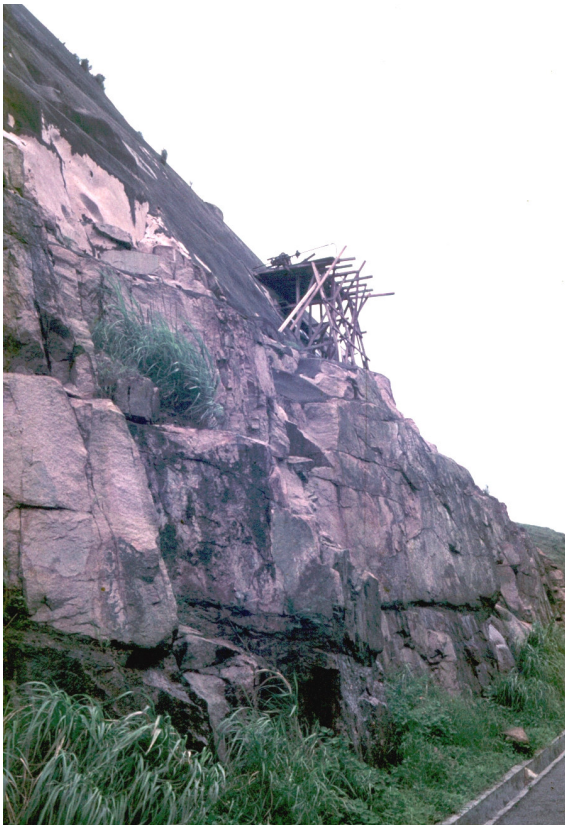
Figure 10: Drilling horizontal drain holes into the face of one of the benches of the Sau Mau Ping slope.

Horizontal drainage holes would be drilled into the slope face to penetrate the potential failure surface in an attempt to reduce uplift pressures in the slope.

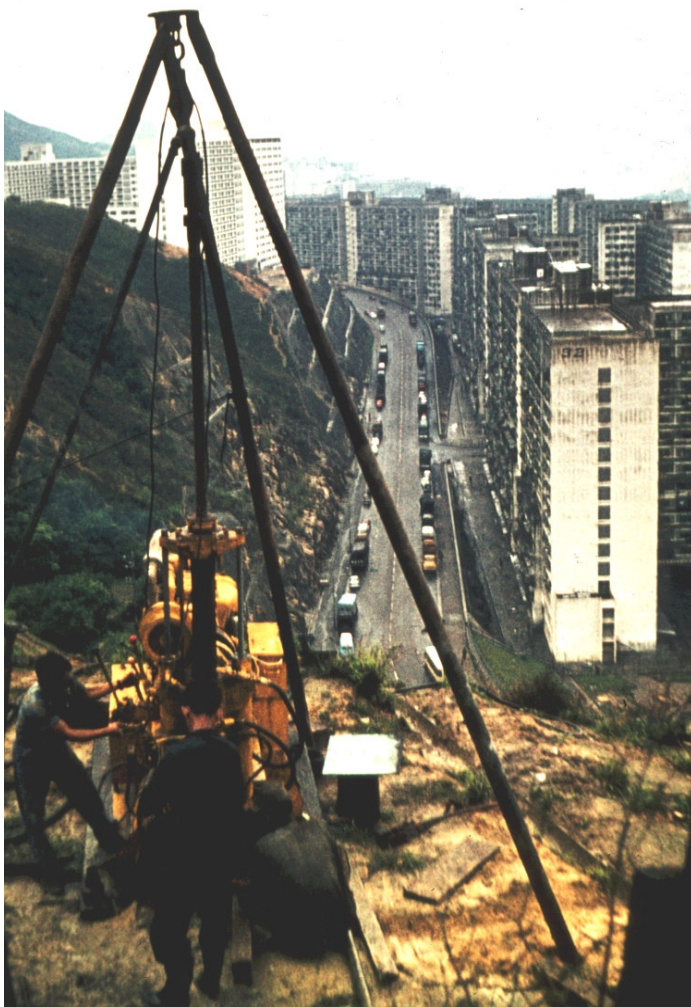
Figure 11: Drilling vertical diamond core holes into the Sau Mau Ping slope. These holes were used for geotechnical investigation purposes and also for the installation of piezometers in the rock mass.

Piezometers would be installed in holes drilled from the top of the slope. These piezometers would be measured regularly during periods of significant rainfall and the road would be closed to traffic if water levels rose to levels decided by the engineers responsible for the project.

Figure 10 shows the drilling of the horizontal drain holes into the slope face and Figure 11 shows the drilling of the vertical holes into which the piezometers were installed. These piezometers were monitored for the next few years, while preparations for the final stabilisation of the slope were made, and the road was closed to traffic on two occasions when water levels were considered to be dangerously high.

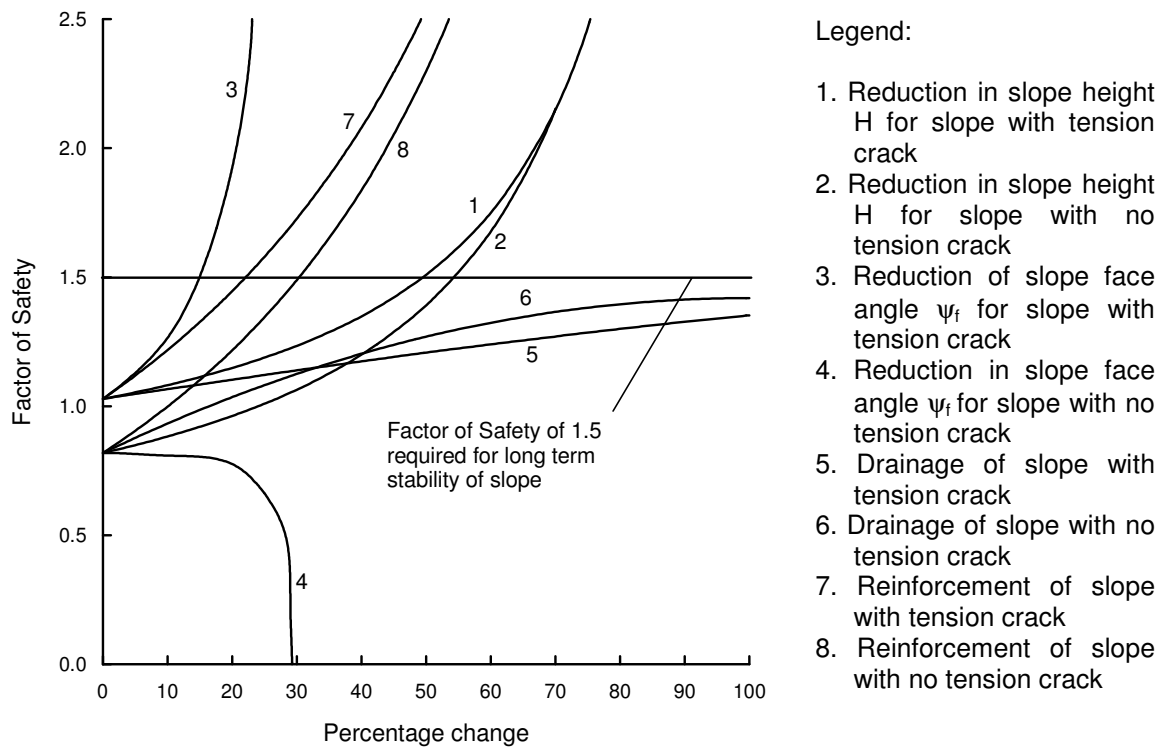
Figure 12: Evaluation of remedial options to increase the stability of the slope

Curves 1 (slope with tension crack) and 2 (slope without tension crack) show that reduction of the slope height is not an effective solution to the problem. In order to achieve the required factor of safety of 1.5, the slope height would have to be reduced by 50%. If this solution were to be adopted, it would be more practical to excavate the entire slope since most of the volume of the rock to be excavated is contained in the upper half of the slope.

Curve 3 (slope with tension crack) shows that reduction of the slope angle is a very effective remedial measure. The required factor of safety of 1.5 is achieved for a reduction of less than 25% of the slope angle. In other words, a reduction of the overall slope face angle from 50° to 37.5° would achieve the desired result. This finding is generally true and a reduction in the face angle of a slope is usually an effective remedial step. In the case of slopes under construction, using a flatter slope is always one of the prime choices for achieving greater stability.

Curves 5 and 6 show that drainage is not a very effective option for either of the slope models considered. In neither case is a factor of safety of 1.5 achieved. This is something of a surprise since drainage is usually one of the most effective and economical remedial measures. The reasons for the poor performance of drainage in this case is due to the combination of the geometry of the slope and the shear strength of the failure surface.

Curves 7 and 8 show that, for both slope models considered, slope reinforcement by means of rockbolts or cables can be an effective remedial measure. The anchor force required for a factor of safety of 1.5 would be about 100 tonnes per metre of slope length for the slope with no tension crack.

The option finally chosen was to reduce the slope face angle down to 35° by excavating the entire block resting on the failure surface and hence removing the problem entirely. Since good quality aggregate is always required in Hong Kong it was decided to work this slope face as a quarry. It took several years to organise this activity and, during this time, the water levels in the slope were monitored by means of piezometers. Although the road was closed twice during this period, no major problems occurred and the slope was finally excavated back to the failure plane.
