Hydroconsolidation (Collapse) Case History

By Thomas F. Blake, Principal Engineering Geologist/Geotechnical Engineer,
Fugro West, Inc., Ventura, California

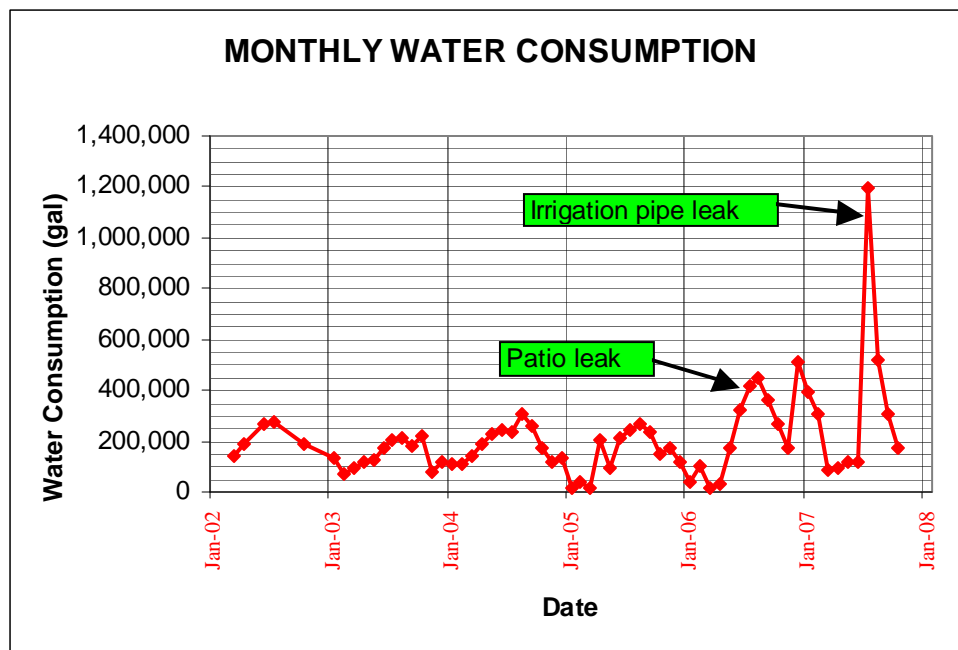
In about mid-2006, the residents at the site began to notice a “darkened area” on the surface of the patio slab that was later determined to be caused by water leaking from a broken pressurized pipeline beneath the slab. Water-use records from 2002 through 2008 (Figure 3), indicate that water consumption on the property approximately doubled at about the time the patio leak developed and remained at that higher rate throughout the latter half of 2006 and into the beginning of 2007. Ownership of the property changed near the end of 2006 and the new property owner located and repaired the patio leak in the early part of 2007. However, by that time, a considerable amount of water had entered the collapsible soil materials beneath the site and signs of significant collapse settlement had become apparent in the rear portion of the residential structure.

Figure 3 - Water consumption data

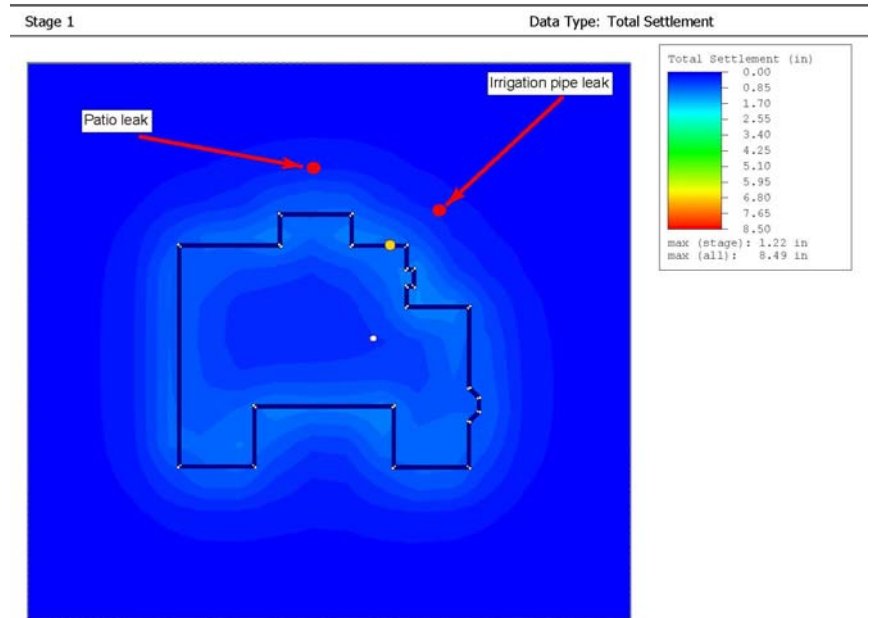
Figure 5a - Stage 1 - Settlement caused by hydroconsolidation settlement only

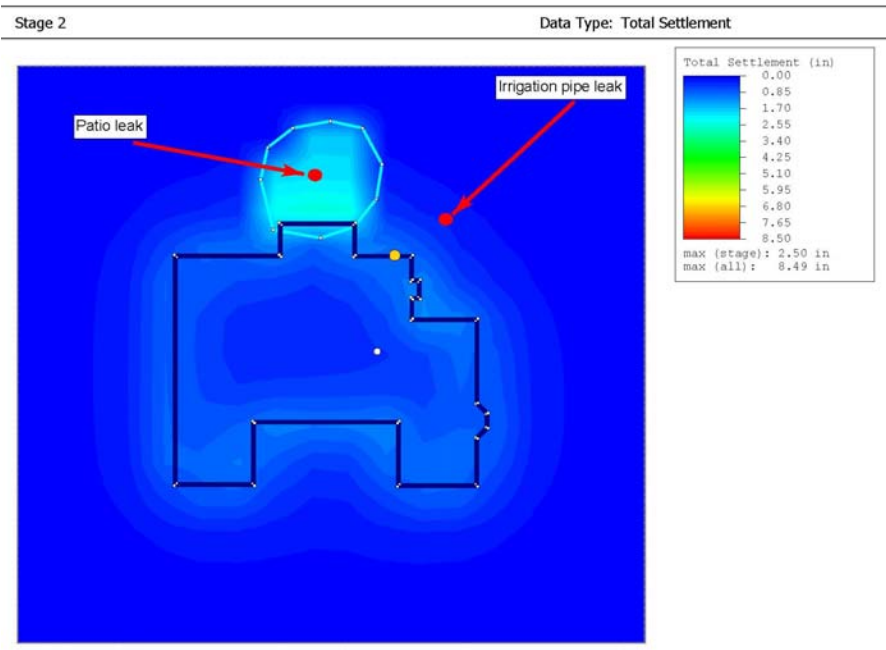
Figure 5b - Stage 2 - Settlement caused by hydroconsolidation settlement only

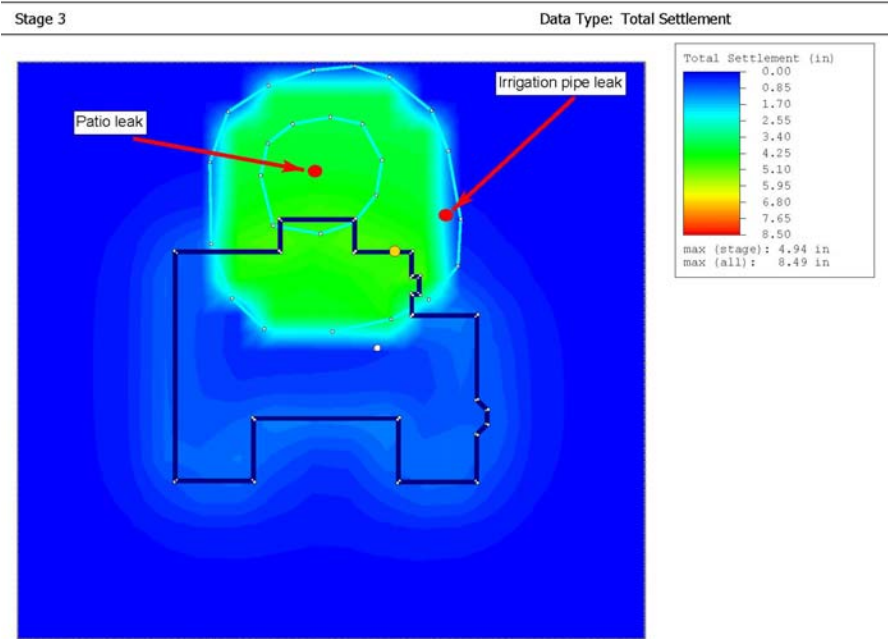
Figure 5c - Stage 3 - Settlement caused by hydroconsolidation settlement only

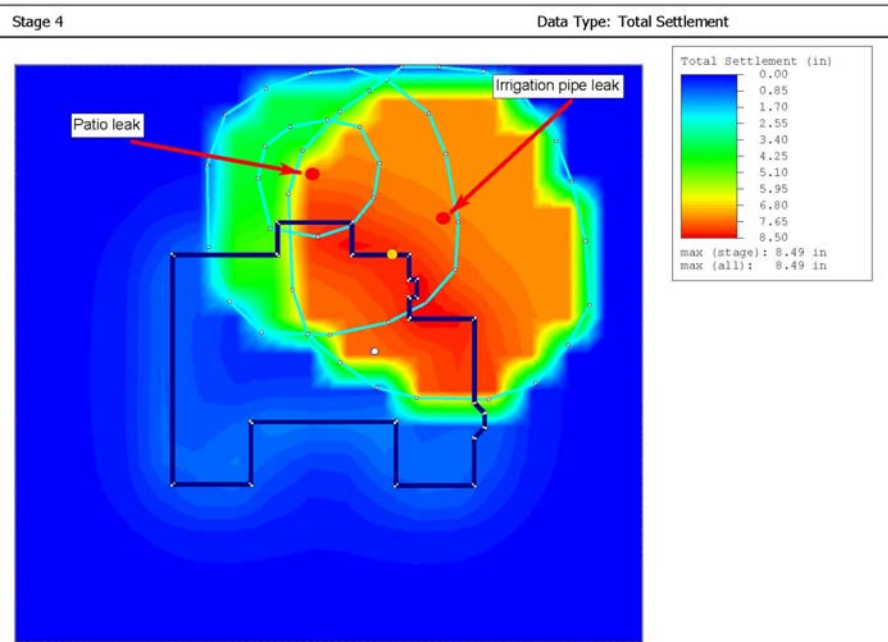
Initially, that model was run using only hydroconsolidation soil properties to estimate the settlement (i.e., the effect of consolidation settlement caused by the increased total unit weight of the soil was neglected). Even assuming that the water leaks saturated the entire 93-foot-thick soil column, from the ground surface to the depth of the underlying bedrock, hydroconsolidation estimates alone (Figures 5a through 5d) were able to account for only about 7 to 8 inches of the observed settlement, which was only about half of the settlement noted at this site.

Figure 5d - Stage 4 - Settlement caused by hydroconsolidation settlement only

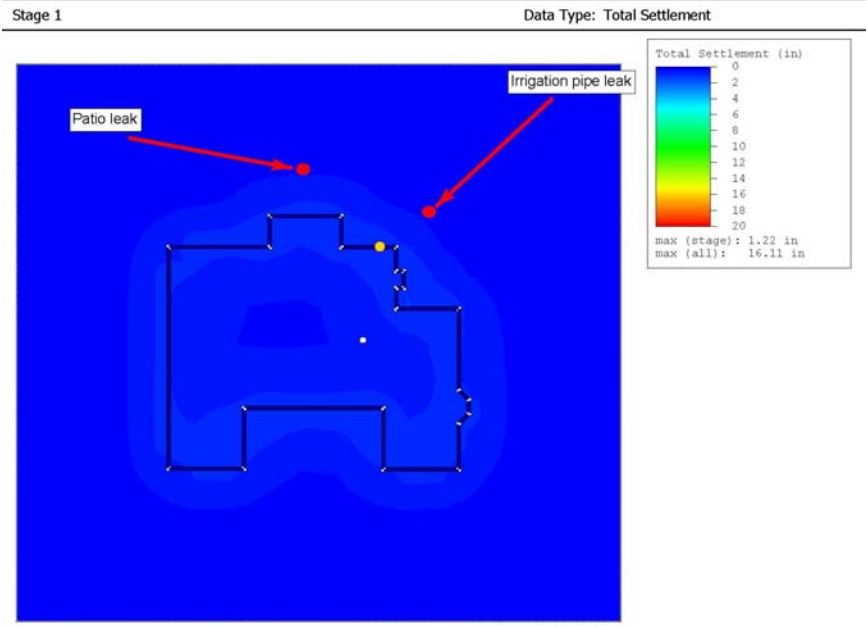
Figure 6a - Stage 1 - Settlement caused by both hydroconsolidation settlement and consolidation settlement, combined

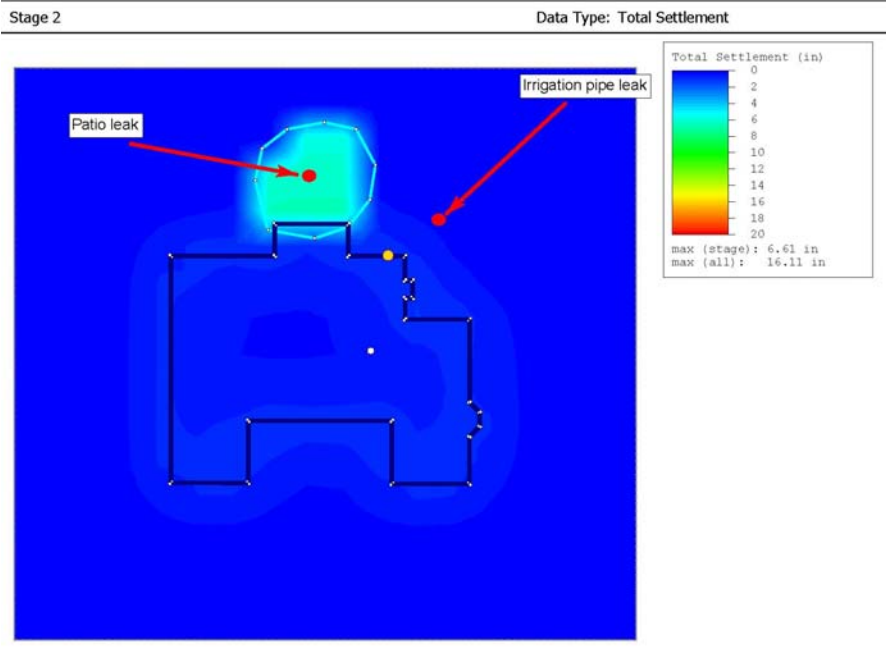
Figure 6b. Stage 2 - Settlement caused by both hydroconsolidation settlement and consolidation settlement, combined

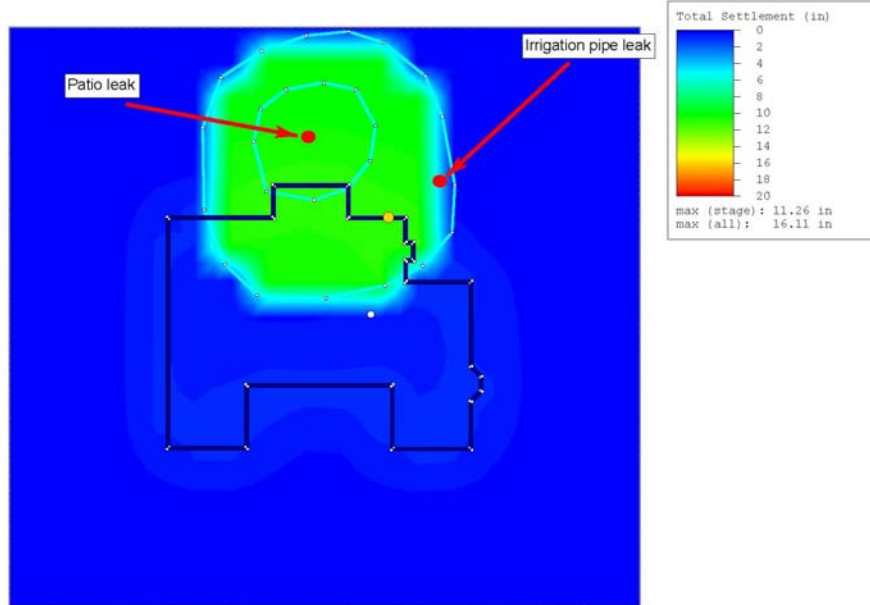
Figure 6c - Stage 3 - Settlement caused by both hydroconsolidation settlement and consolidation settlement, combined

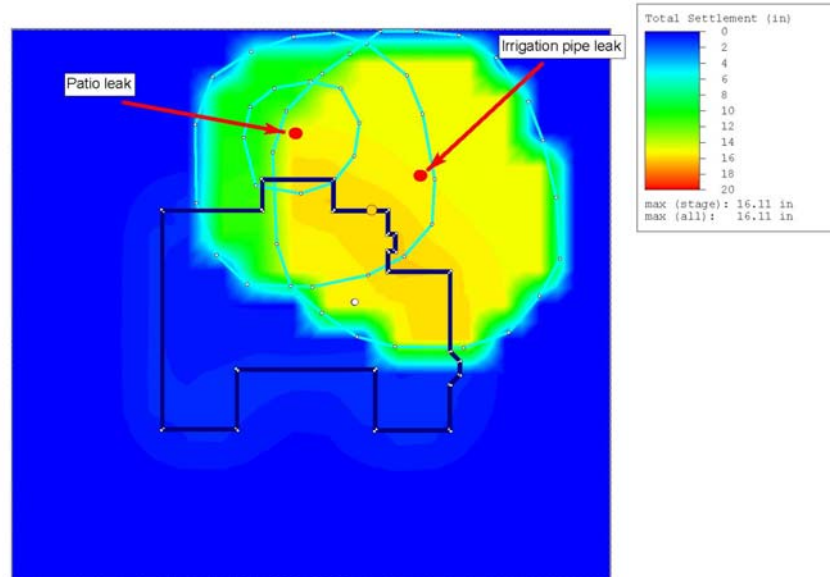
Therefore, the analysis was repeated by including the additional consolidation settlement that would result from a 10 pcf increase in unit weight. The result was a combined collapse and consolidation settlement estimate of about 16 inches (Figures 6a through 6d). Although no quantitative settlement measurements were ever made at the site, the combined settlement estimate of about 16 inches is believed to be consistent with the magnitude of the distress observed at the site.

Figure 6d - Stage 4 - Settlement caused by both hydroconsolidation settlement and consolidation settlement, combined
