THISSAVROS HYDROPOWER PLANT MANAGING GEOTECHNICAL PROBLEMS IN THE CONSTRUCTION

K. Anastassopoulos
Public Power Corporation
Athens, Greece

E. Hoek
Consultant
North Vancouver, Canada

ABSTRACT

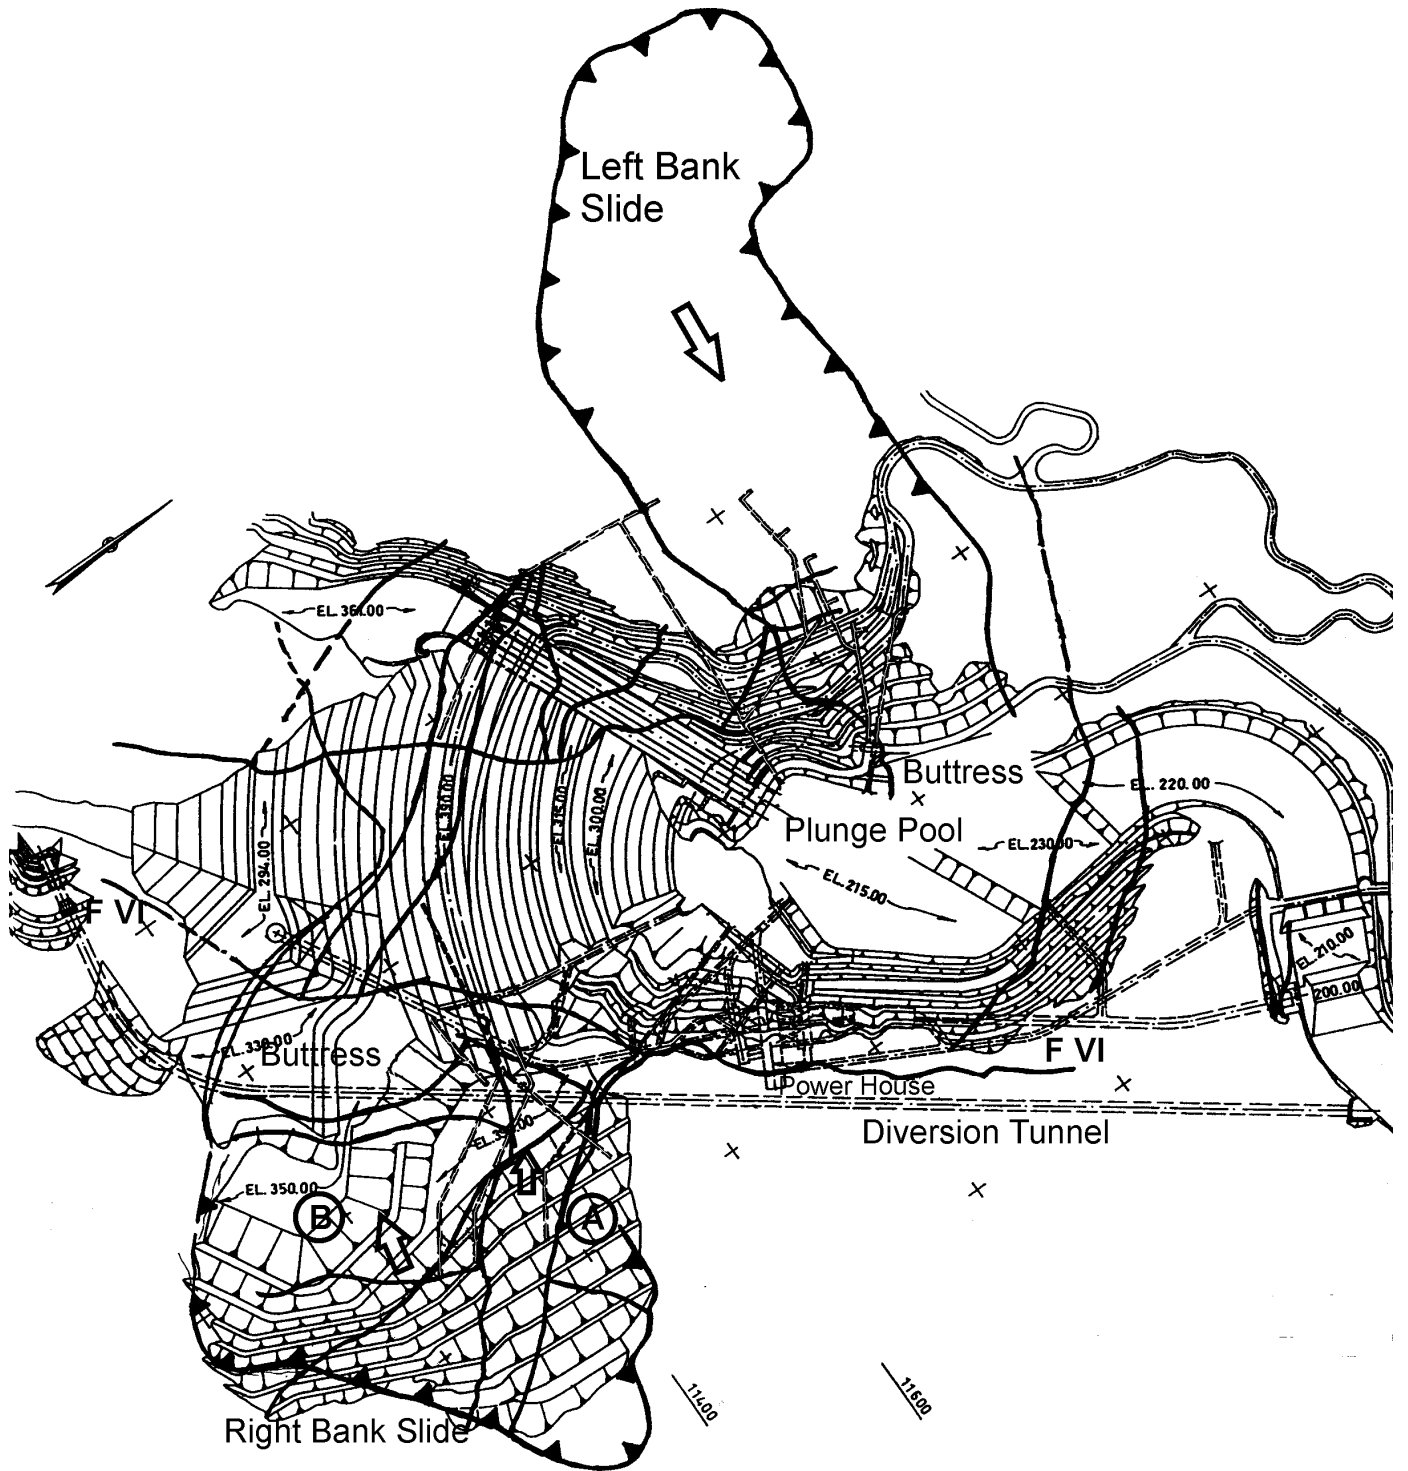
Figure 1. Dam site and landslides. Heavy lines mark faults. Coordinate grid on 200 m spacing

Two significant areas of instability developed at the site (see Fig. 1); these are discussed further below.

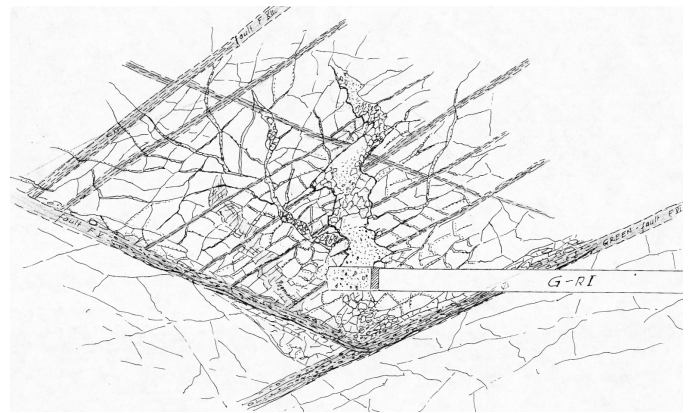
Figure 3. Collapse of grouting gallery in Segment A of landslide

At the base of Segment A, the rock mass of very poor quality is wedged between Faults V and VI. The rock is partially weathered to the point of becoming friable, partially decomposed, and only about 25% of the pieces retain their original strength. Internal deformation of the sliding rock is indicated by irregular

orientation of the foliation planes. When the lower right-bank grouting tunnel entered this zone, a major collapse occurred that also affected the intermediate grouting tunnel, located 40 m higher in the slope (Fig. 3). In consequence of this collapse, the material in the center of the wedge deteriorated even more. The poor quality rock near the center and base of the sliding wedge did not permit systematic Lugeon testing but the limited number of tests gave a notable permeability for the slide mass, on the order of 10^{-5} m/s, but lower than for the adjacent in-situ rock. According to grain size distribution, the permeability of the soils produced by alteration of the gneiss was estimated to range from 10^{-4} to 10^{-3} m/s but presumably core drilling did not recover representative samples from the soils. Fines appear to have been lost.

Remedial measures for the right bank included major excavation and stripping to unload the head of the unstable mass, toe buttressing and drainage. Unloading the head of the landslide in Segment A by excavation of 1.65 million m^3 , combined with subhorizontal drain holes that dropped the groundwater levels by 10m, stopped the initial movements in 1988. However, preparatory excavation for the power intake caused the slide to accelerate again to a rate of 17 mm/day in early 1989. This time, 0.9 million m^3 were removed at the head of Segment B, and a toe buttress placed between El. 280 and 420 m definitely stopped the displacements of the slide mass. The final volume of excavation for unloading arrived at 2.6 million m^3 .

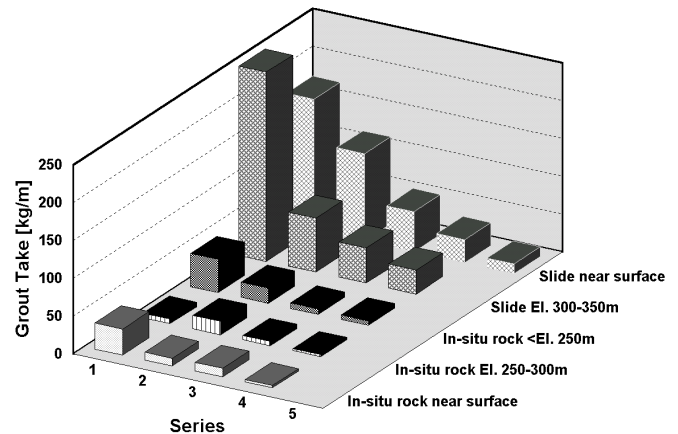
decomposed material. Initially, traditional slurries with water/cement ratios of 2 and 1 by weight and addition of 1 to 2% bentonite were applied. However, the large takes indicated an uncontrolled reach and, therefore, slurries with a ratio of only 0.6 were used in the event that high takes were experienced. With such dense slurry, the initial treatment of the collapse absorbed 20 tonnes of cement. Grout take averaged about 250 kg/m in the primary series and dropped progressively to only 13 kg/m in the final series (see Fig. 4). In comparison, the primary series in in-situ rock absorbed less than 70 kg/m on average. Grout pressures ranged from 1 bar at the top to 15 bar at the lower fringe of the curtain. According to Lugeon tests at the end of the construction works the permeability in Segment A had reduced to 10^{-6} m/s. Considering that compaction grouting had been done at quite low pressures, this result is satisfactory. The ample quantity of grout found in the cores of the check holes conveyed an even more favorable impression of the success of the work.

Figure 4. Development of grout takes on the right bank

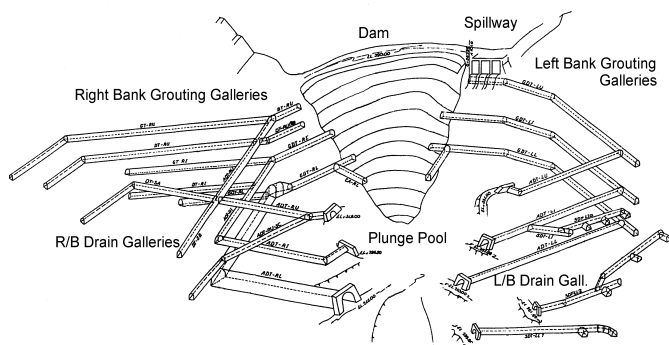
Figure 5. Schematic view of arrangement of grouting and drainage galleries

To achieve efficient drainage of the slide mass, to intercept seepage percolating through the grout curtain and to prevent build-up of undesirable groundwater loads against the steep slope along the right bank downstream of the dam, a system of galleries is provided (see Fig. 5). Two parallel galleries at the upper level partially traverse the slide mass of Segment A above Fault F VI. One drainage gallery at the intermediate level also intersects Fault F VI. At the lower level, one gallery serves the combined purpose of grouting and drainage. Seepage water in the drain holes is captured by slotted PVC screens, wrapped with geotextile to prevent erosion of fines. The screens can be pulled for maintenance. Standard spacing of drain holes is at 6 m centers.

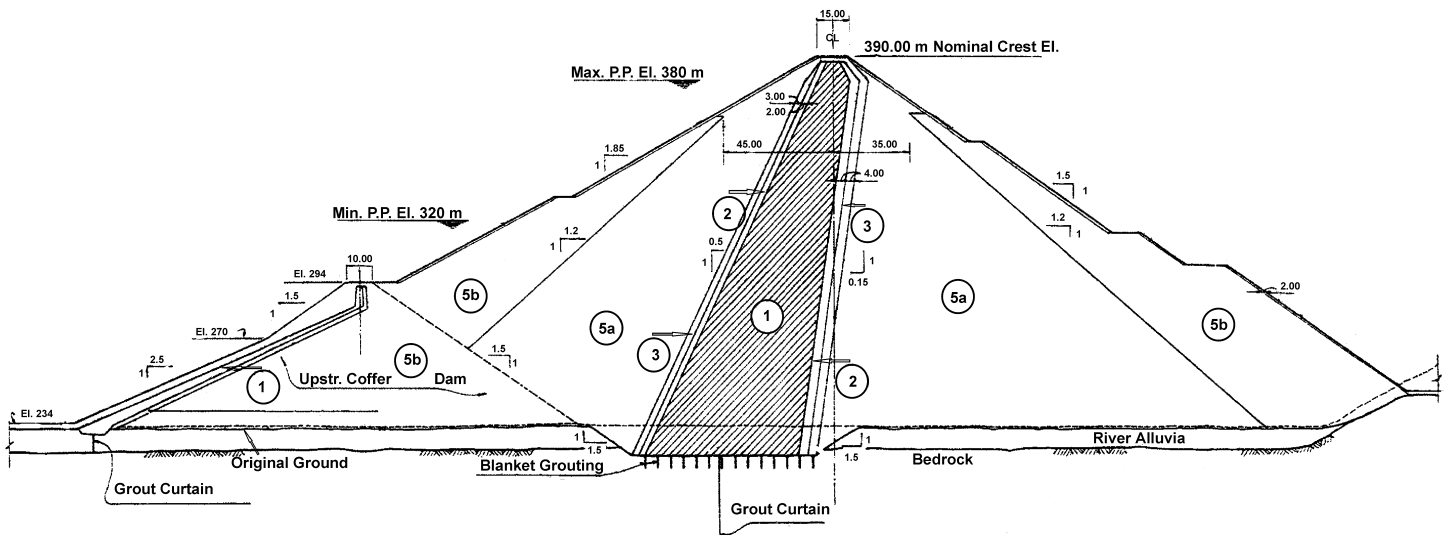
section). Fig. 8 shows the typical cross section and Table 2 summarizes the characteristics of the different zones of the dam.

Figure 8. Typical section of rockfill dam. Description of zones see Table 2

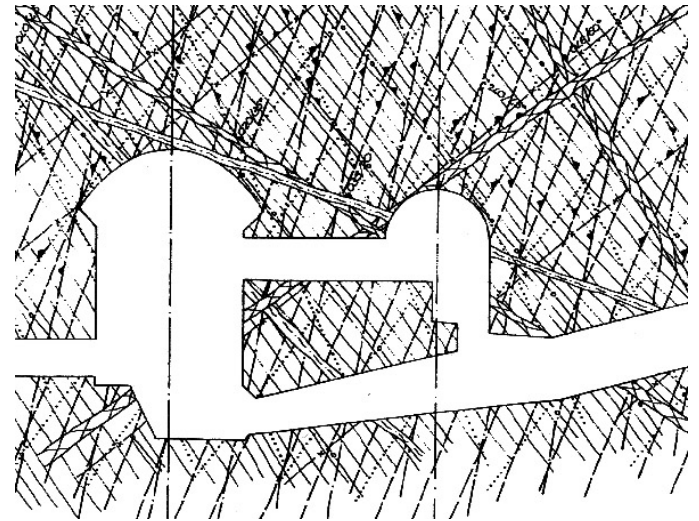
The toe buttressing of the left bank landslide changed the situation in the plunge pool and required modifying the layout of the power house (see Figures 1 and 7). In consequence of the modification, the axis of the cavern lies parallel to the foliation of the gneiss but fortunately the foliation planes were undulated, with the orientation of the poles scattering by about 40° . The foliation, joints, faults and shears created a hazard of wedge failures in the crown and the sidewalls of the caverns (see Fig. 9). But, irrespective of the adverse rock mass fabric, wedge analysis

Figure 9. Generator and transformer caverns, pattern of rock mass discontinuities

concurrent with the excavation achieved safe support with little overbreak. An innovative design provided for cast in place crane beams which, before the main benching work started, were anchored to the walls and connected to the cavern roof concrete liner. The beams supported a construction gantry used for installation of rockbolts and shotcrete for roof and wall support and for concrete works. These crane beams were later incorporated into the main crane support. Table 3 describes the support installed in the power cavern.
