# **The construction of the Egnatia highway through unstable slopes in northern Greece**

P. Marinos and E. Hoek

Presented at the XI Conference on Rock Mechanics, Turin, November 2006

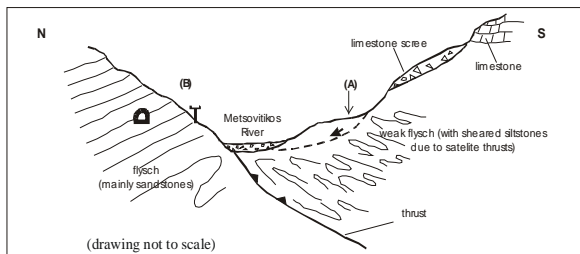
4.1.1 In the Metsovitikos valley masses of competent formations (limestones) have overthrust the soft and “ductile” flysch. The former comprises the highest parts of the southern valley sides forming high cliffs which produce screes covering the flysch of the lower parts which are deformed and sheared due to the overthrusting. The screes allow water to percolate and moisten the geotechnically poor mass of flysch. Earthflows as well as old and new landslides are typical phenomena, often on impressive scales on such slopes. Additionally, the development of this instability of the flysch undermines the limestone crests of the slopes provoking further falls of limestone masses which further weaken the flysch slopes downhill. Such unstable areas were avoided by a realignment of the motorway to the north side of the valley where more competent sandstone flysch is present away from the thrust (fig. 3 & 4). The length of the relocated alignment is almost 5km (Kazilis and Georganopoulos 1999).

Figure 3: Drive through the section at the Metsovitikos valley. The initial alignment (A) was selected through a mild topography. However, this morphology was due to a series of old landslides in unstable flysch. Extensive drainage including drainage galleries of 5km of length were proposed. Solution: relocation of alignment at the northern, steep but stable, slopes of Metsovitikos River where sandstone flysch occurs (B) with tunnels alternating with bridges.

The northern alignment has an apparent disadvantage in terms of the increased length and the number of tunnels involved. However, the risks, both during construction and subsequent operation were considered to be lower than the problems associated with the unstable slopes of the southern alignment. The quality of the rock mass along the northern alignment is such that tunnelling problems were expected to be minimal. This was indeed the case as this section of the highway is already constructed in operation.

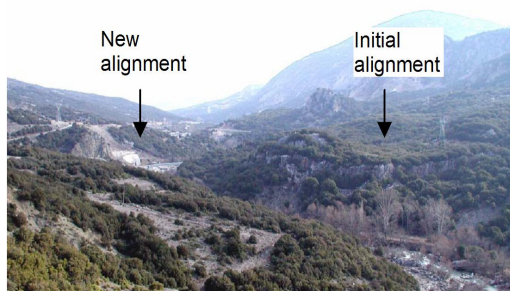
4.1.2 A similar case of a generous realignment of the Egnatia axis exists further to the west of the highway in the Peristeri area. The initial axis was selected due to the mild and friendly morphology (fig. 5). However this morphology was the result of a tongue of landslide debris of limestones over the flysch. These huge limestone blocks still move over their weak basement at depths of about 50m at rates of 1 to 2cm per year (fig. 6).

Figure 5 View of the Peristeri area. At the right of the picture the south side of valley showing the large limestone blocks in gentle slopes of landslide debris. The alignment of the highway initially selected at the south has been moved to the north side of the valley

A realignment to the north side was necessary. Old landslides occur also in the new position of the highway but these are of a size that can be stabilised effectively.

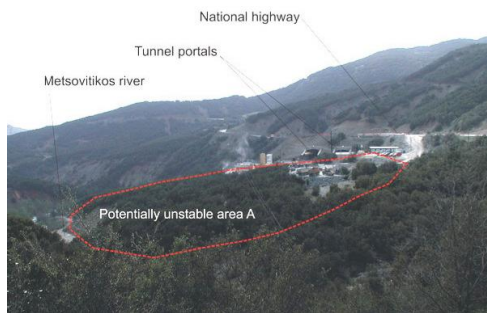
This potential slide is within old landslide debris which overlies bedrock consisting of conglomerates and sandstone flysch. Inclinometers in the slope have indicated deeper movements than had been previously assumed and the magnitude of these movements has accelerated with the increase in construction activities associated with the creation of the portals and the mining of the adjacent tunnels (figure 7). The indications from these measurements are that the slide surface is probably coincident with the boundary between the overburden and the bedrock and that the slope is marginally stable. Groundwater conditions in the slope have been monitored by a number of piezometers which indicate that the present groundwater level is high.

Figure 7: Potential instability in area that will be crossed by the Egnatia highway under the national highway. The portals of tunnel indicate the alignment of the Egnatia highway.

The designer has proposed drainage of the slope as the primary remedial option and that this drainage would be achieved by one or more drainage tunnels. In order to evaluate these proposals and to examine other remedial options, we carried out a number of crude stability studies to explore the sensitivities of the proposed solutions rather than to offer a specific design. The results from one of these studies are presented in Figure 8.

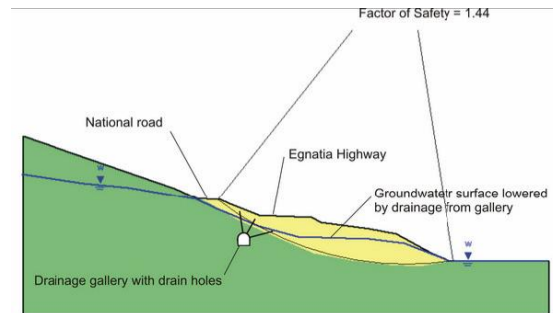
Figure 8: Stability analysis of the existing slope with partial drainage by means of a drainage gallery in bedrock with drainage holes penetrating the assumed failure surface. The factor of safety for the overburden/bedrock interface failure surface is shown as 1.44.

3. Drainage of the slope, as illustrated in Figure 8, results in a significant improvement in the factor of safety<sup>1</sup>. In the case illustrated, partial drainage of the slope is achieved from a single drainage gallery in the bedrock with inclined drainage holes drilled into the overlying overburden. It has been assumed that the groundwater table is drawn down by a rather modest amount at the head of the slide but left largely unchanged at the toe of the slope. The increase of factor of safety from 1.00 to 1.44 for partially drained conditions suggests that there is good potential for optimizing the drainage measures to achieve the required improvement in stability.

drain holes near the toe of the slope. These drains can usually be installed very quickly and they will have an immediate beneficial effect. Because of ongoing movements in the slope some of these drainage holes would be damaged over time but by then the primary drainage function would have been taken over by the drainage gallery.

On the basis of experience in other projects in which drainage galleries have been used successfully it is suggested that the drainage tunnel must be located in bedrock. The cost of constructing a gallery (5m diameter) within the slide material is approximately three times the cost of mining it in the bedrock and, in addition, high ongoing maintenance costs are associated with a tunnel in deforming ground. The drain holes have to be filtered in order to prevent erosion of fines from the overburden material and it has to be recognized that cleaning and/or re-drilling of these holes will be required periodically in order to ensure that the drainage system remains effective.

An essential requirement for a successful drainage program is careful monitoring of the groundwater surface through a good number of piezometres both before and after the implementation of the drainage scheme.

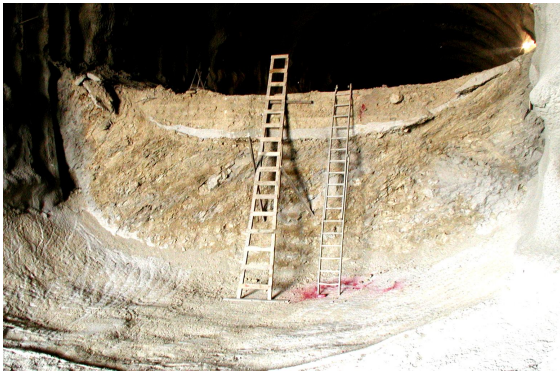
Figure 11: Appearance of the phyllitic formation in the face of the remaining bench of tunnel S3. The well preserved structure of the rock mass is clearly visible in this face.

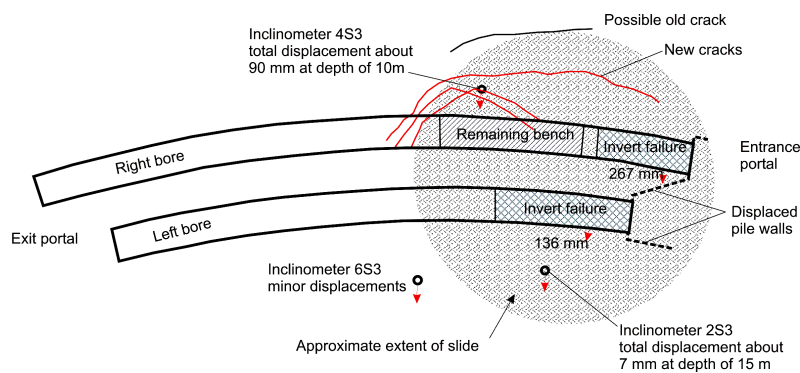
Ongoing downslope movements were recorded in the tunnels, on surface and by means of inclinometers installed in the slope. These measurements, together with observations of the cracks, suggest that a shallow slide had occurred in the vicinity of the Entrance Portal and that the tunnels and portal structure were moved downhill. The maximum recorded downslope movement was of the order of 270 mm and the movements were ongoing (fig. 13 & 14).

Figure 13: Simplified plan showing most significant features related to slope instability in the area of the entrance portal of tunnel S3. (scale: length of right bore: 260m)

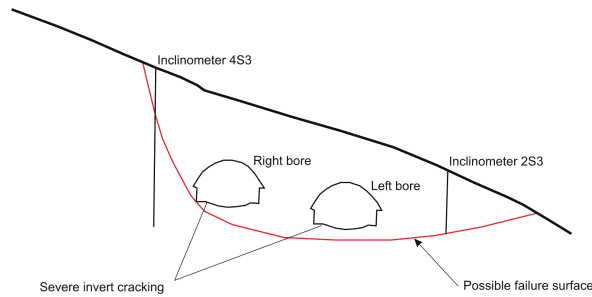
Figure 14: Possible slide geometry through inclinometers 4S3 and 2S3 including the tunnel S3. (scale: failure in 4S3 at a depth of 10m and in 2S3 of 15m)

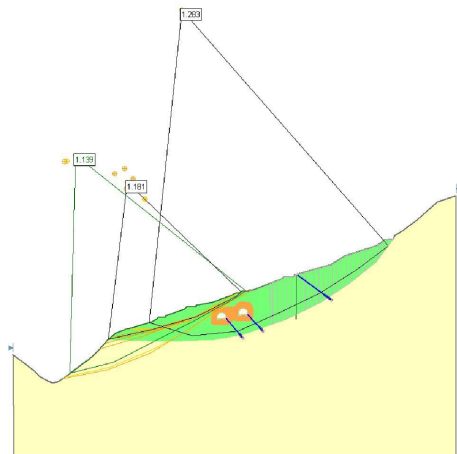
The designer performed detailed analyses but figure 15 present our own crude analyses of the remedial measure to check their effectiveness. Although this analysis is not an exact simulation of the FLAC studies performed by the Contractor's Designer, it illustrates that the solution is effective and that the factor of safety for the tunnels is approximately 1.3. The low factors of safety for the lower part of the slope are questionable since the material properties have been crudely estimated in this area. The steep lower slope suggests that these properties are probably too low and higher shear strength values were assumed for this area in subsequent analyses.

Figure 15 Approximate analysis of remedial proposals by Contractor's Designer with a grouted rock mass surrounding the tunnels, 1000 kN anchors installed from the tunnels and an anchored pile wall to protect the gas pipeline on the upper road.

- A pile wall uphill to prevent any propagation of the slide and protect a gas pipe crossing the site. This pile wall was tied back with long stressed anchors.
- 
- Stressed anchors from inside the tunnels. These are the most important component of the slope stabilization process.
- 
- Grouting. The purpose was to strengthen the pillar and the surrounding mass of the tunnels and to improve the foundations for the anchors.
-

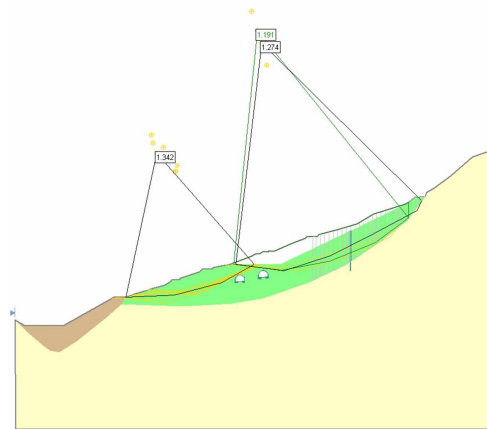
Figure 16. Alternative solution with a significant unloading of the upper part of the slope. It was suggested that the excavated material be used to buttress the slope against a potential deep slide.

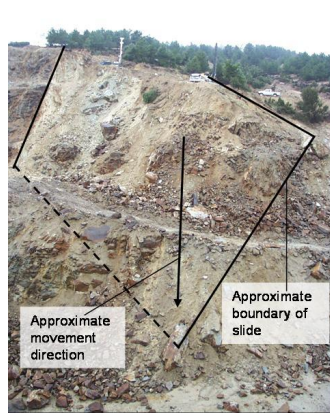
The highway cuts a granitic mass near the city of Kavala in eastern Greece. The granite is crossed by a sequence of faults almost normal to the road axis and dipping generally  $50^\circ$  to  $70^\circ$  to the south west. Many of these faults are associated with mylonites and sheared zones of clayey material. These weak zones, associated with other discontinuities, may form wedge like rock slides. Such a slide occurred during construction and is shown in figure 17 with a total vertical height of approximately 47m.

Figure 17: Photograph of landslide in Kavala section in a granitic mass showing approximate slide boundaries and movement direction.

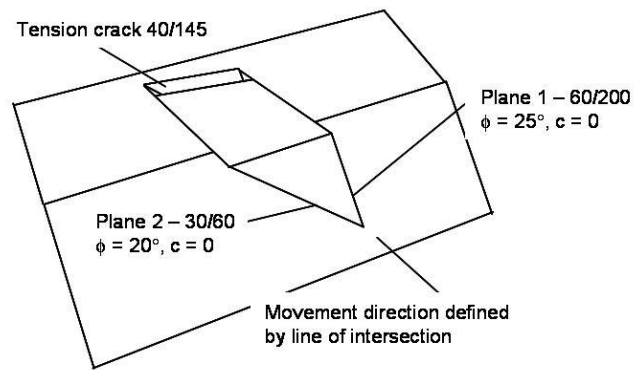
Based upon the interpretation of the core drilling results, the orientation of surface outcrops, the records of observations and measurements and the overall appearance of the slide, it was possible to construct a simplified slope failure model such as that illustrated in Figure 18. This figure can give a reliable indication of changes in factor of safety for various remedial actions. The trend of the results provided an adequate basis for the final decision regarding the measures to apply (figure 19).

Figure 18. Model of landslide of figure 17 created using the program Swedge ([www.roscience.com](http://www.roscience.com))

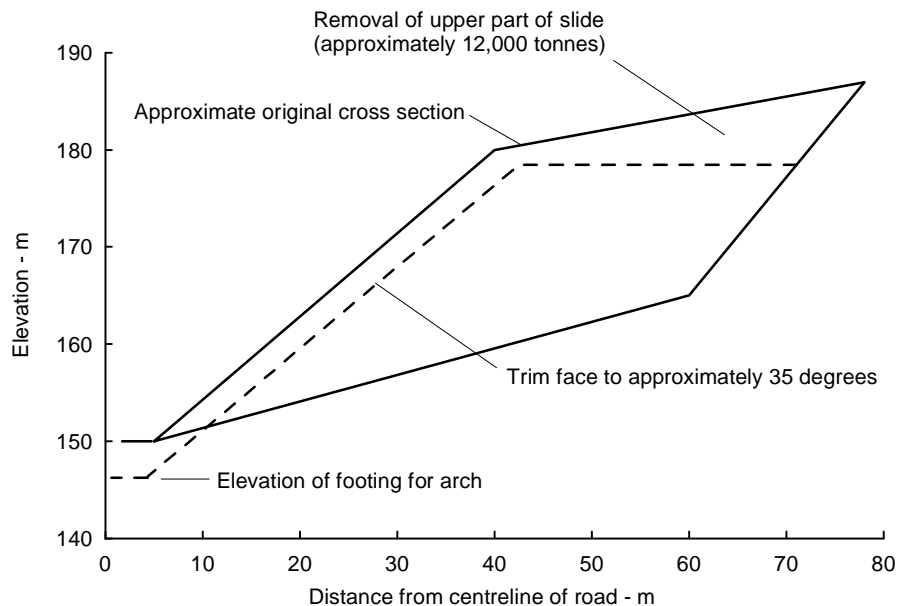
Geometry	Factor of safety
Original slope	1.02
Original slope with upper part of slide removed	1.33
Slope toe excavated to footing level and slope trimmed back to 35 degrees	1.53
Backfill placed against slope	Approximately 4

Figure 19. Original cross-section of slope and possible revision to slope geometry (shown as a dashed line). Approximate factors of safety for various conditions are given in the table. These are based on indicative analyses to demonstrate the change of factor of safety with changes in slope geometry.

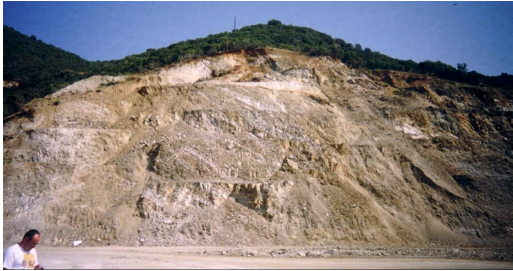
Although these crystalline rock masses exhibit good behaviour, shear zones can be combined with other discontinuities of various orientations when the mass is quite jointed and produce rotational slides. Such a slide is shown in figure 20 and 21 in the eastern part of the highway. Unloading of the slope was the applied solution.

Figure 20. Landslide at the Asprovalta area, controlled by the presence of joints and shear faults producing rotational slides. Notice the intact structure of sound gneiss inside the sliding mass

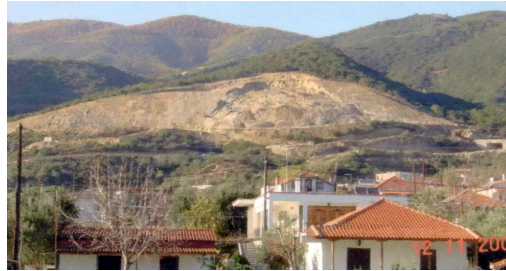
Figure 21. The landslide of figure 20. the rotational failure is clear

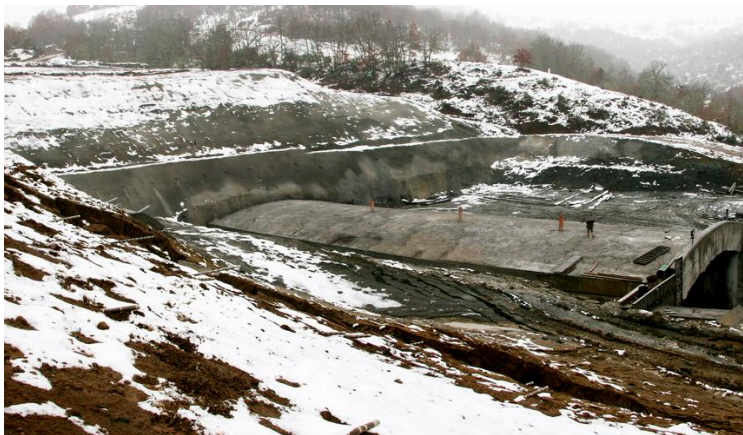
Figure 22. Kiloma tunnel exit portal in molassic rocks showing cover and cut construction and small surficial slide on the left hand side of the photograph. The cover and cut structure protected the portal from further development of this slide.

Molasse, being vulnerable to weathering, is much weaker close to the surface. In a number of portals of tunnel of the highway in these rocks the solution of cover and cut construction was adopted instead of open cuts (figure 22).

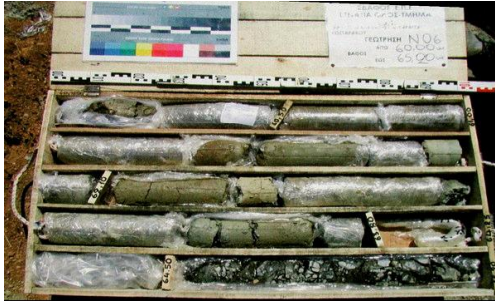
Figure 24 Core of weak ophiolites recovered from borehole NO6 behind the Big Cut at depths from 60 to 65 m below surface. Pieces of clayey like transformed serpentine are present.

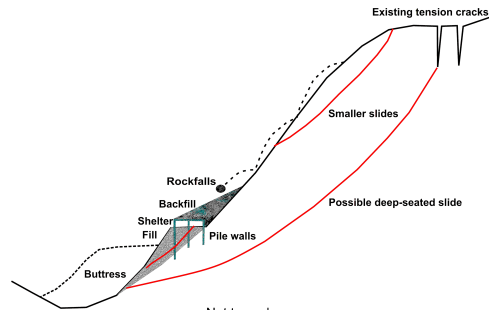
Figure 25: Potential failure modes in the “Big Cut” (not to scale). The sketch illustrates a number of possible alternative solutions. None of these solutions have been adopted and the highway has been moved onto a high fill in the bottom of the valley.
