# **The construction of the Egnatia highway through unstable slopes in northern Greece**

P. Marinos and E. Hoek

Presented at the XI Conference on Rock Mechanics, Turin, November 2006

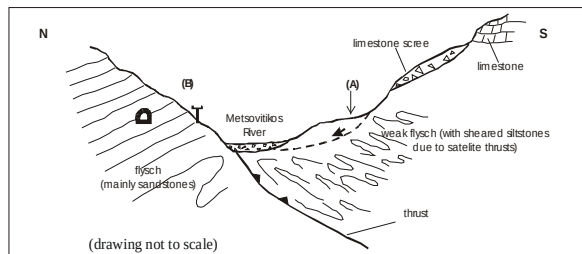
4.1.1 In the Metsovitikos valley masses of competent formations (limestones) have overthrust the soft and “ductile” flysch. The former comprises the highest parts of the southern valley sides forming high cliffs which produce screes covering the flysch of the lower parts which are deformed and sheared due to the overthrusting. The screes allow water to percolate and moisten the geotechnically poor mass of flysch. Earthflows as well as old and new landslides are typical phenomena, often on impressive scales on such slopes. Additionally, the development of this instability of the flysch undermines the limestone crests of the slopes provoking further falls of limestone masses which further weaken the flysch slopes downhill. Such unstable areas were avoided by a realignment of the motorway to the north side of the valley where more competent sandstone flysch is present away from the thrust (fig. 3 & 4). The length of the relocated alignment is almost 5km (Kazilis and Georganopoulos 1999).

Figure 3: Drive through the section at the Metsovitikos valley. The initial alignment (A) was selected through a mild topography. However, this morphology was due to a series of old landslides in unstable flysch. Extensive drainage including drainage galleries of 5km of length were proposed. Solution: relocation of alignment at the northern, steep but stable, slopes of Metsovitikos River where sandstone flysch occurs (B) with tunnels alternating with bridges.

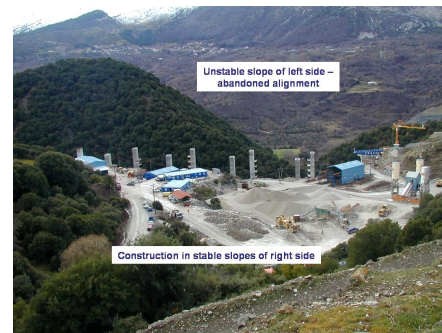
Figure 4 Construction works at the north side of Metsovitikos valley after the realignment of the highway in the Metsovo section in order to avoid globally unstable slopes at the south side of the valley

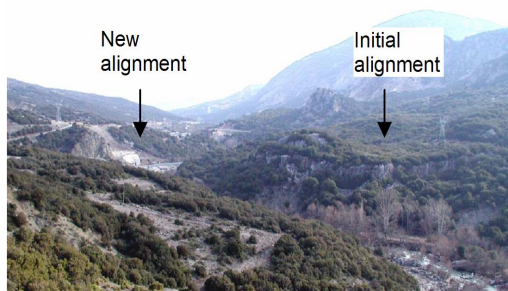
4.1.2 A similar case of a generous realignment of the Egnatia axis exists further to the west of the highway in the Peristeri area. The initial axis was selected due to the mild and friendly morphology (fig. 5). However this morphology was the result of a tongue of landslide debris of limestones over the flysch. These huge limestone blocks still move over their weak basement at depths of about 50m at rates of 1 to 2cm per year (fig. 6).

Figure 5 View of the Peristeri area. At the right of the picture the south side of valley showing the large limestone blocks in gentle slopes of landslide debris. The alignment of the highway initially selected at the south has been moved to the north side of the valley

A realignment to the north side was necessary. Old landslides occur also in the new position of the highway but these are of a size that can be stabilised effectively.

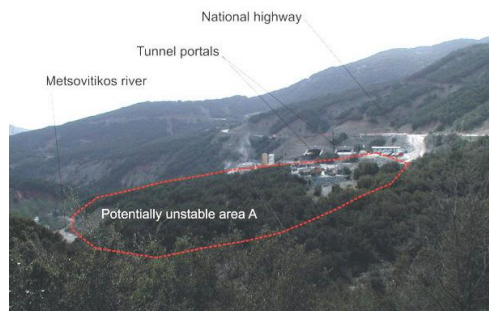
This potential slide is within old landslide debris which overlies bedrock consisting of conglomerates and sandstone flysch. Inclinometers in the slope have indicated deeper movements than had been previously assumed and the magnitude of these movements has accelerated with the increase in construction activities associated with the creation of the portals and the mining of the adjacent tunnels (figure 7). The indications from these measurements are that the slide surface is probably coincident with the boundary between the overburden and the bedrock and that the slope is marginally stable. Groundwater conditions in the slope have been monitored by a number of piezometers which indicate that the present groundwater level is high.

Figure 7: Potential instability in area that will be crossed by the Egnatia highway under the national highway. The portals of tunnel indicate the alignment of the Egnatia highway.

The designer has proposed drainage of the slope as the primary remedial option and that this drainage would be achieved by one or more drainage tunnels. In order to evaluate these proposals and to examine other remedial options, we carried out a number of crude stability studies to explore the sensitivities of the proposed solutions rather than to offer a specific design. The results from one of these studies are presented in Figure 8.

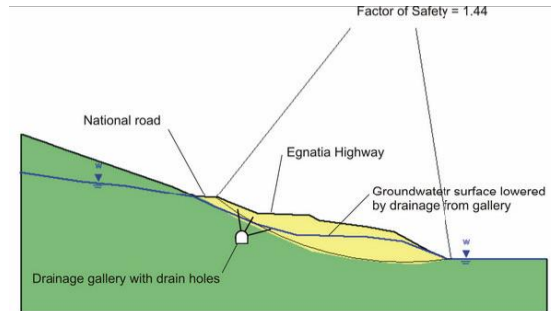
Figure 8: Stability analysis of the existing slope with partial drainage by means of a drainage gallery in bedrock with drainage holes penetrating the assumed failure surface. The factor of safety for the overburden/bedrock interface failure surface is shown as 1.44.

3. Drainage of the slope, as illustrated in Figure 8, results in a significant improvement in the factor of safety<sup>1</sup>. In the case illustrated, partial drainage of the slope is achieved from a single drainage gallery in the bedrock with inclined drainage holes drilled into the overlying overburden. It has been assumed that the groundwater table is drawn down by a rather modest amount at the head of the slide but left largely unchanged at the toe of the slope. The increase of factor of safety from 1.00 to 1.44 for partially drained conditions suggests that there is good potential for optimizing the drainage measures to achieve the required improvement in stability.

When construction schedule demands that drainage measures to improve stability are required before a drainage gallery can be completed, consideration should be given to the drilling of a series of horizontal

drain holes near the toe of the slope. These drains can usually be installed very quickly and they will have an immediate beneficial effect. Because of ongoing movements in the slope some of these drainage holes would be damaged over time but by then the primary drainage function would have been taken over by the drainage gallery.

On the basis of experience in other projects in which drainage galleries have been used successfully it is suggested that the drainage tunnel must be located in bedrock. The cost of constructing a gallery (5m diameter) within the slide material is approximately three times the cost of mining it in the bedrock and, in addition, high ongoing maintenance costs are associated with a tunnel in deforming ground. The drain holes have to be filtered in order to prevent erosion of fines from the overburden material and it has to be recognized that cleaning and/or re-drilling of these holes will be required periodically in order to ensure that the drainage system remains effective.

An essential requirement for a successful drainage program is careful monitoring of the groundwater surface through a good number of piezometres both before and after the implementation of the drainage scheme.

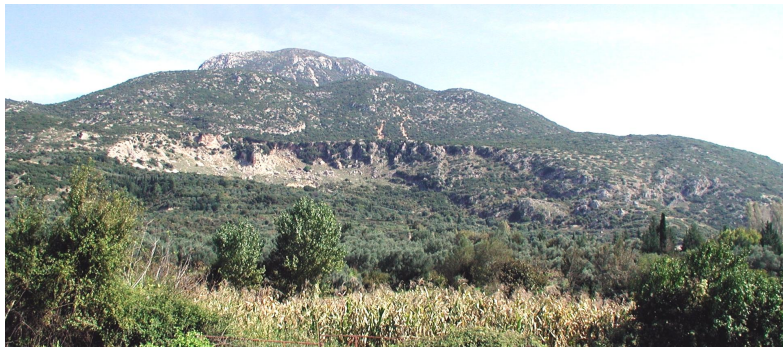
4.2.2 One other case where the highway alignment cannot avoid a significant and deep landslide is shown in figure 9 (Krystallopigi area in the westernmost part of the highway). An embankment will be used for this crossing.

Figure 9 Frontal view of the ancient Krystallopigi landslide which will be crossed by the highway

In this case the base of the mountain slopes consist of flysch and, in some areas, of the underlying series of the Ionian limestones. Over these formations a comprehensive series of the Ionian limestones has been thrust. These limestones are heavily fractured or even brecciated.

The exposed part of the flysch on the slopes, weakened by water, suffered in the past from landslides which undermined the overlying limestones and generating rock falls in a similar manner to that described in paragraph 4.1. Debris from these falls cover the flysch lying on the lower parts of the slope, adding to their disturbance and assisting the water penetration into the slope.

The area is thus undergoing a dynamic geomorphological process that has formed the amphitheatric scarp delineating the actual limits of the landslide and this process is still evolving. The most likely interpretation of the fact that the underlying weak flysch improves in depth into the slope is that it may not allow the development of huge slides at the mountain slope scale but creep movement and smaller slides cannot be excluded. Indeed creep is present in the slope and some inclinometers inside the main mass have recorded rates of movement of few tens of millimetres since 1998. The question that arises is whether these ongoing geomorphological processes can affect the highway. As mentioned, the landslide will be crossed by an embankment and remedial measures will include a long drainage gallery. Consideration also is given to assist drainage by drilling of vertical wells into the permeable underlying limestone.

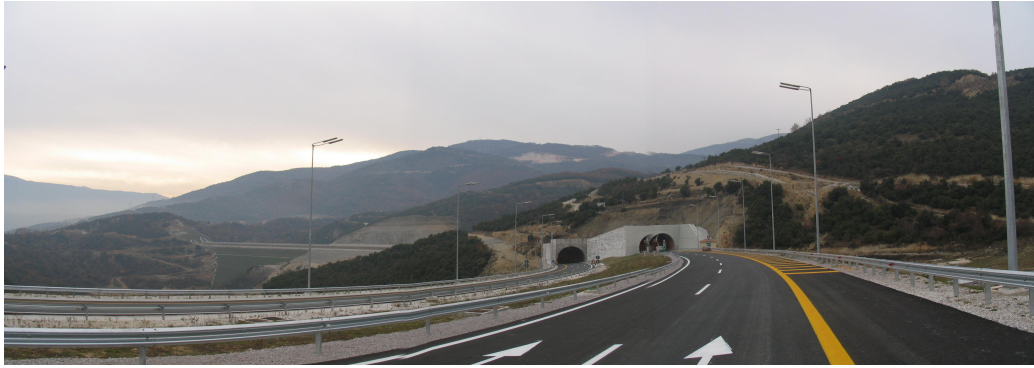
4.2.3 A most particular case consist the crossing of an unstable slope with a tunnel. The tunnel, of a length of 260m, named S3, is located in the central section of the highway (figure 10).

Figure 10. The tunnel S3 in the central part of the highway from the entrance portal, crossing an unstable slope stabilized during the construction

These measures have been implemented and the tunnel is already in operation (figure 10).

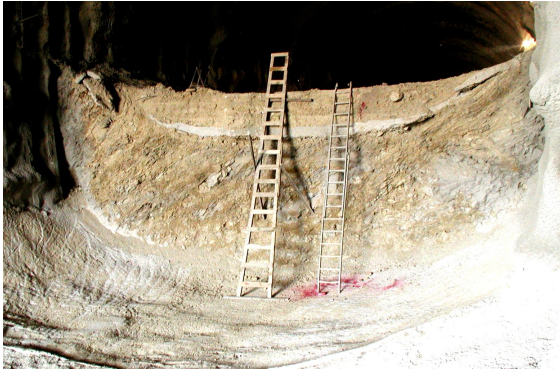
Figure 11: Appearance of the phyllitic formation in the face of the remaining bench of tunnel S3. The well preserved structure of the rock mass is clearly visible in this face.

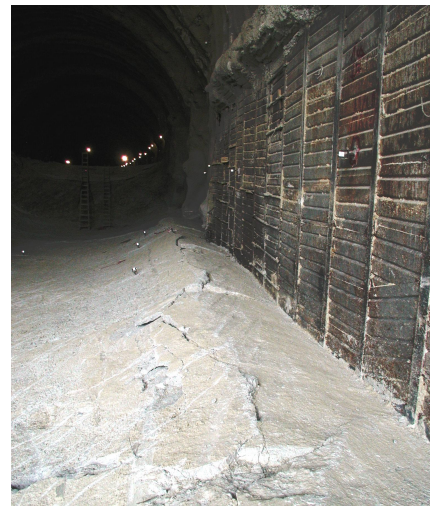
The slope is of phyllites (figure 11) and no signs of instability were found when selecting this route for the highway. However, driving of the was suspended because cracking inside the tunnel and on surface gave rise to a concern that the slope in the vicinity of the entrance portal was unstable and that these conditions did not permit safe advance of the tunnel. The final invert cracked for a distance of approximately 60 m inwards from the entrance portal (figure 12).

Figure 12: Severe invert cracking near the entrance portal of the S3 tunnel.

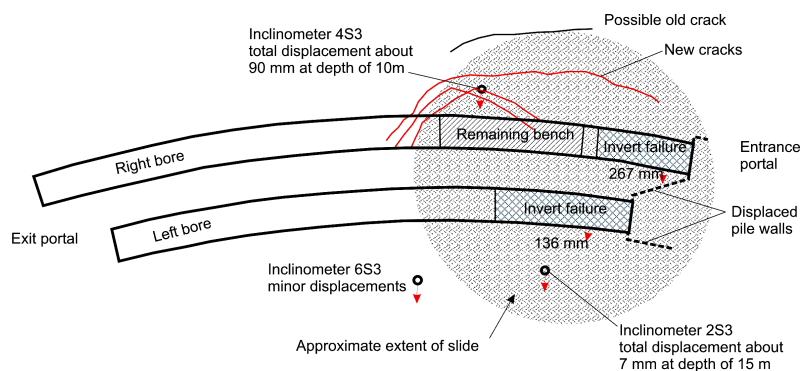
Ongoing downslope movements were recorded in the tunnels, on surface and by means of inclinometers installed in the slope. These measurements, together with observations of the cracks, suggest that a shallow slide had occurred in the vicinity of the Entrance Portal and that the tunnels and portal structure were moved downhill. The maximum recorded downslope movement was of the order of 270 mm and the movements were ongoing (fig. 13 & 14).

Figure 13: Simplified plan showing most significant features related to slope instability in the area of the entrance portal of tunnel S3. (scale: length of right bore: 260m)

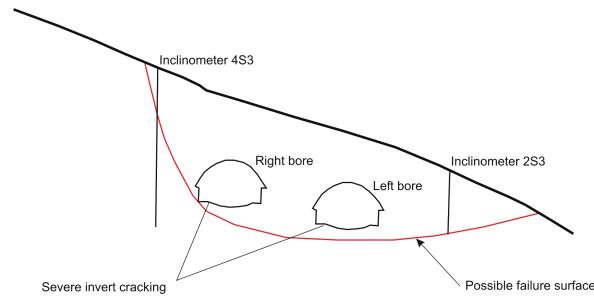
Figure 14: Possible slide geometry through inclinometers 4S3 and 2S3 including the tunnel S3. (scale: failure in 4S3 at a depth of 10m and in 2S3 of 15m)

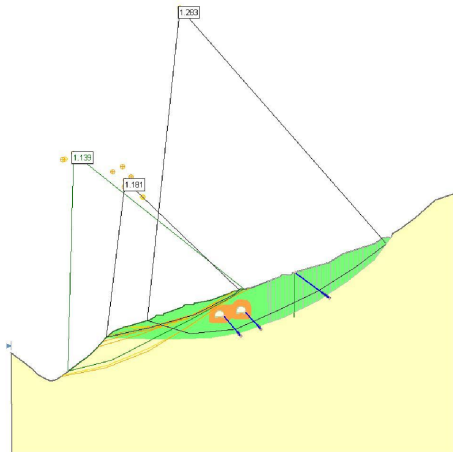
Figure 15 Approximate analysis of remedial proposals by Contractor's Designer with a grouted rock mass surrounding the tunnels, 1000 kN anchors installed from the tunnels and an anchored pile wall to protect the gas pipeline on the upper road.

- A pile wall uphill to prevent any propagation of the slide and protect a gas pipe crossing the site. This pile wall was tied back with long stressed anchors.
- 
- Stressed anchors from inside the tunnels. These are the most important component of the slope stabilization process.
- 
- Grouting. The purpose was to strengthen the pillar and the surrounding mass of the tunnels and to improve the foundations for the anchors.
-

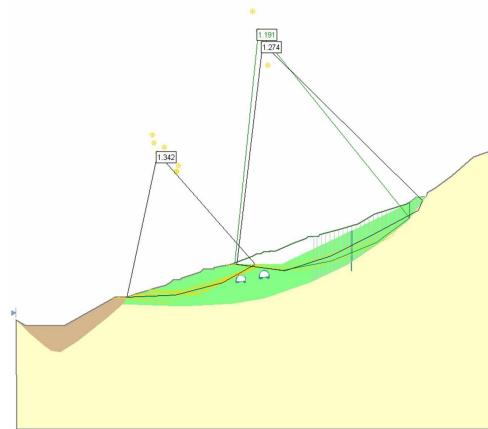
Figure 16. Alternative solution with a significant unloading of the upper part of the slope. It was suggested that the excavated material be used to buttress the slope against a potential deep slide.

Figure 16 gives a simple analysis for an alternative possibility with removal of a part of the slide and buttressing the valley against any potential deeper failure. The analyses illustrated in figs 15 and 16 were performed using the program Slide ([www.rocscience.com](http://www.rocscience.com))

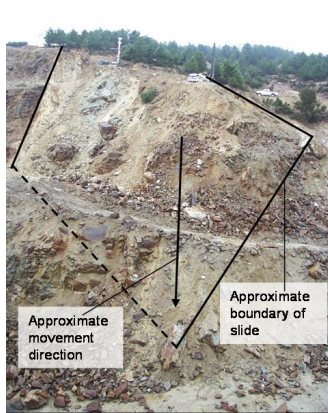
The highway cuts a granitic mass near the city of Kavala in eastern Greece. The granite is crossed by a sequence of faults almost normal to the road axis and dipping generally  $50^\circ$  to  $70^\circ$  to the south west. Many of these faults are associated with mylonites and sheared zones of clayey material. These weak zones, associated with other discontinuities, may form wedge like rock slides. Such a slide occurred during construction and is shown in figure 17 with a total vertical height of approximately 47m.

Figure 17: Photograph of landslide in Kavala section in a granitic mass showing approximate slide boundaries and movement direction.

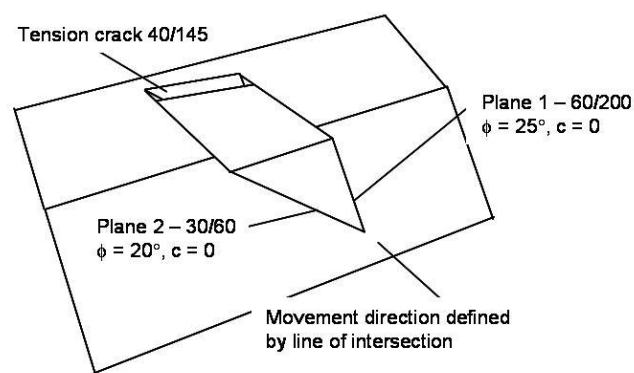
Figure 18: Model of landslide of figure 17 created using the program Swedge ([www.roscience.com](http://www.roscience.com))

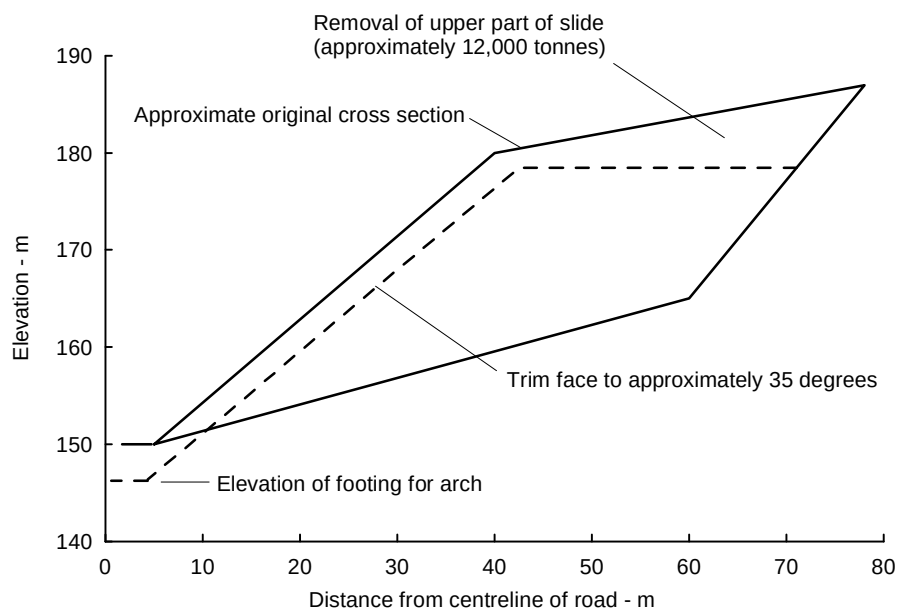
| Factors of safety (with water present in slope) | |
|---|---|
| Original slope | 1.02 |
| Original slope with upper part of slide removed | 1.33 |

Figure 19. Original cross-section of slope and possible revision to slope geometry (shown as a dashed line). Approximate factors of safety for various conditions are given in the table. These are based on indicative analyses to demonstrate the change of factor of safety with changes in slope geometry.

Based upon the interpretation of the core drilling results, the orientation of surface outcrops, the records of observations and measurements and the overall appearance of the slide, it was possible to construct a simplified slope failure model such as that illustrated in Figure 18. This figure can give a reliable indication of changes in factor of safety for various remedial actions. The trend of the results provided an adequate basis for the final decision regarding the measures to apply (figure 19).

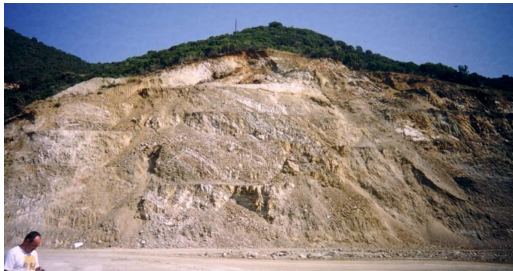
Although these crystalline rock masses exhibit good behaviour, shear zones can be combined with other discontinuities of various orientations when the mass is quite jointed and produce rotational slides. Such a slide is shown in figure 20 and 21 in the eastern part of the highway. Unloading of the slope was the applied solution.

Figure 20. Landslide at the Asprovalta area, controlled by the presence of joints and shear faults producing rotational slides. Notice the intact structure of sound gneiss inside the sliding mass

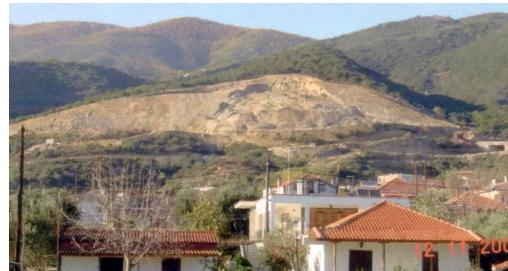
Figure 21. The landslide of figure 20. the rotational failure is clear

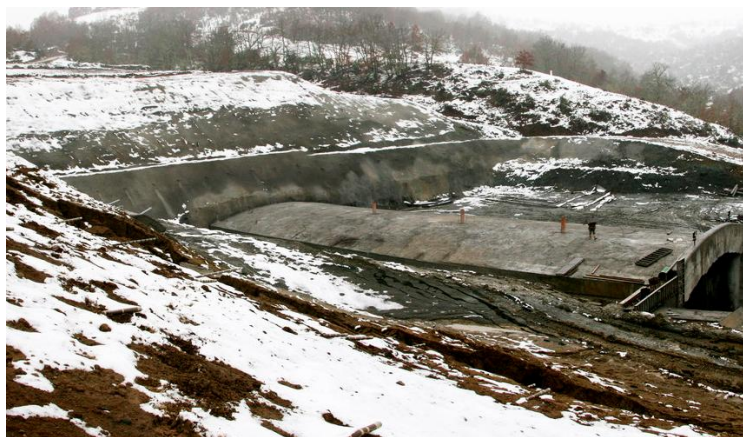
Figure 22. Kiloma tunnel exit portal in molassic rocks showing cover and cut construction and small surficial slide on the left hand side of the photograph. The cover and cut structure protected the portal from further development of this slide.

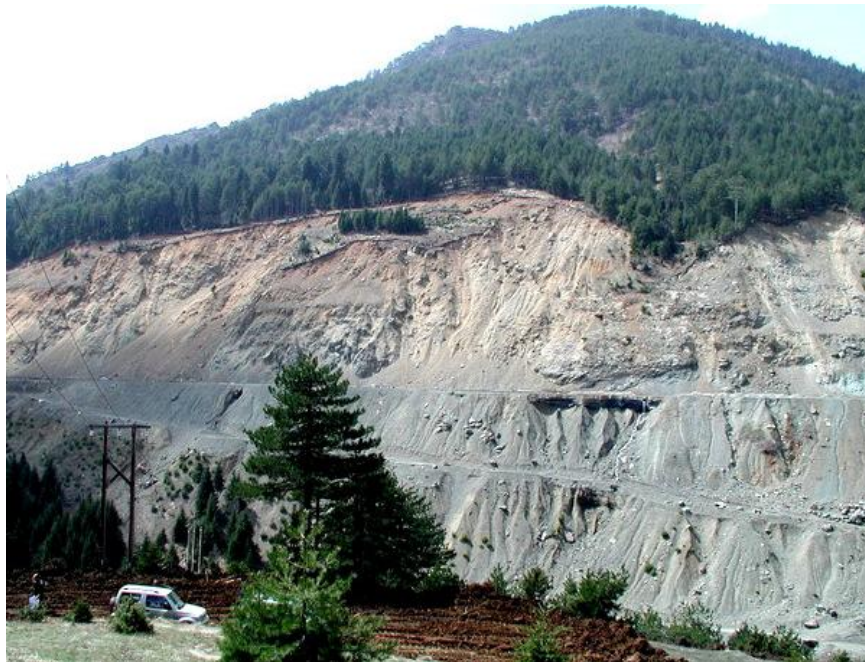
The ophiolitic mass crossed by the Egnatia highway in the Katara area presents irregular serpentinisation of the good quality peridotite that is the persistent rock. This process has produced weak rock masses which have been further degraded by the intense tectonic shearing. This shearing is quite severe in this area in which the whole ophiolitic mass, part of an ancient ocean floor, was thrust over the Pindos formations. Even when peridotites are sound, smooth serpentinised films coat the joints of the rocks facilitating structural instability.

Another risk associated with this cut is from the possibility of generation of rockfalls. Several rockfalls have occurred since the slope was excavated and it has to be anticipated that such rockfalls will continue. In order to deal with this hazard a rockfall shelter was initially considered. However, this proved to be impractical because it was not considered feasible to design a structure wide enough to protect both carriageways. Finally it was decided to move the highway alignment onto a high fill on the valley floor.

Figure 23 General appearance of Big Cut with the Egnatia Highway platform running across the centre of the picture. The slope is a peridotite with disordered serpentinisation and tectonic shearing

The remedial measures that were applied initially involved a series of piles along the toe of the slope at the level of the highway. A drainage layer was installed at the same level. These piles were intended to provide "shear pins" across the interface between the fill and the underlying rock mass. Given the conditions of the whole mass, concern with this system is that it depends upon the location of the potential failure surface. Weak zones were detected at depth in borehole cores (fig 24), during later site investigations. If such deeper weak layers fail then the piles will only serve to tie the fill together to create a larger failure (figure 25). Indeed the structure of the mass suggests that it is entirely possible that a failure surface can find its way along the weakest path through this rock mass which, in terms of slope stability analysis, can be treated as "homogeneous" due to the erratic distribution of weak zones. Under such conditions and in order to accommodate the second carriageway under the "Big Cut", a stability and sensitivity analysis study of different alternatives was performed. Stabilisation of the toe of the slope by a buttressing counterweight, with additional drainage, was found as the most effective solution.

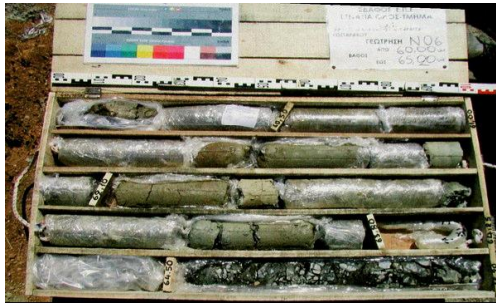
Figure 24 Core of weak ophiolites recovered from borehole NO6 behind the Big Cut at depths from 60 to 65 m below surface. Pieces of clayey like transformed serpentine are present.

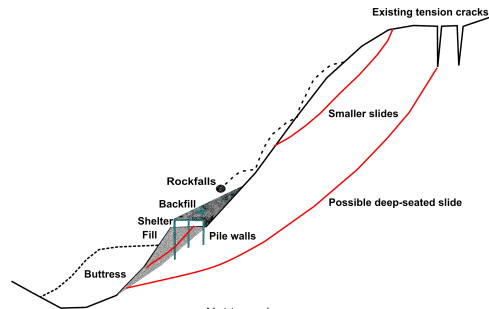
Figure 25: Potential failure modes in the “Big Cut” (not to scale). The sketch illustrates a number of possible alternative solutions. None of these solutions have been adopted and the highway has been moved onto a high fill in the bottom of the valley.
