When is a rock engineering design acceptable

Introduction

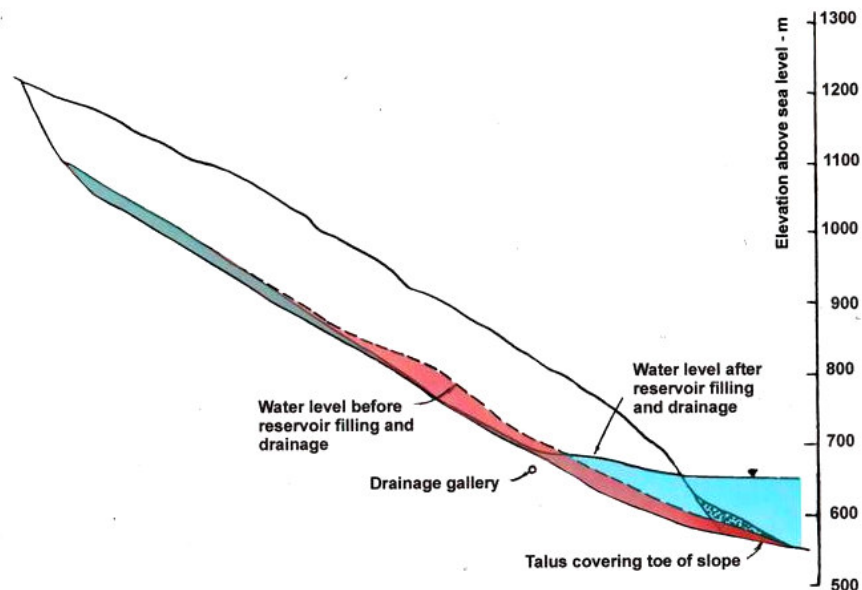
Figure 1: Section through Dutchman's Ridge showing potential slide surface and water levels before and after drainage.

Comparative studies of the stability of the slope section shown in Figure 1, based upon a factor of safety of 1.00 for the slope after reservoir filling but before implementation of the drainage system, gave a factor of safety of 1.06 for the drained slope. This 6% improvement in factor of safety may not seem very significant to the designer of small scale rock and soil slopes but it was considered acceptable in this case for a number of reasons:

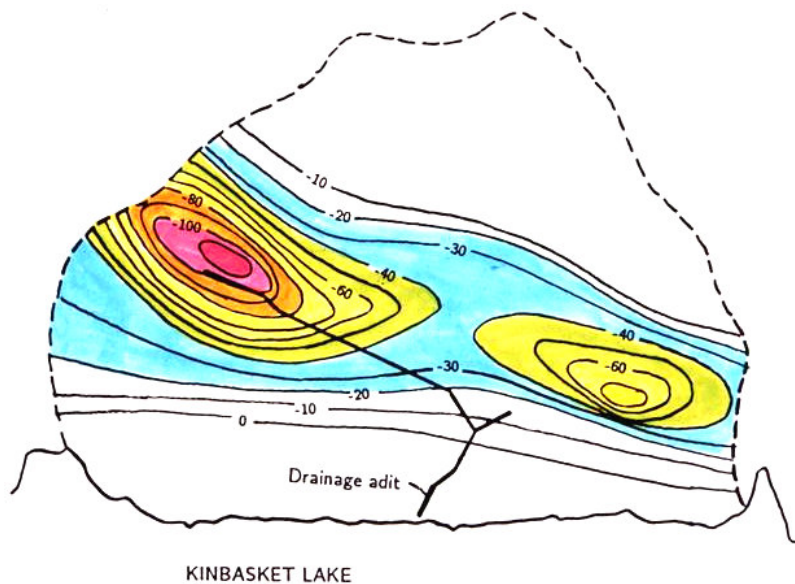
Figure 2: Contours of water level reduction (in metres) as a result of the implementation of drainage in Dutchman's Ridge.

2. The groundwater levels in the slope were reduced by drainage to lower than the pre-reservoir conditions and the stability of the slope is at least as good if not better than these pre-reservoir conditions. This particular slope is considered to have withstood several significant earthquakes during the 10,000 years since the last episode of glaciation which is responsible for the present valley shape.
3. Possibly the most significant indicator of an improvement in stability, for both the Downie Slide and Dutchman's Ridge, has been a significant reduction in the rate of down-slope movement which has been monitored for the past 25 years. In the case of the Downie Slide, this movement has practically ceased. At Dutchman's Ridge, the movements are significantly slower and it is anticipated that they will stabilize when the drainage system has been in operation for a few more years.

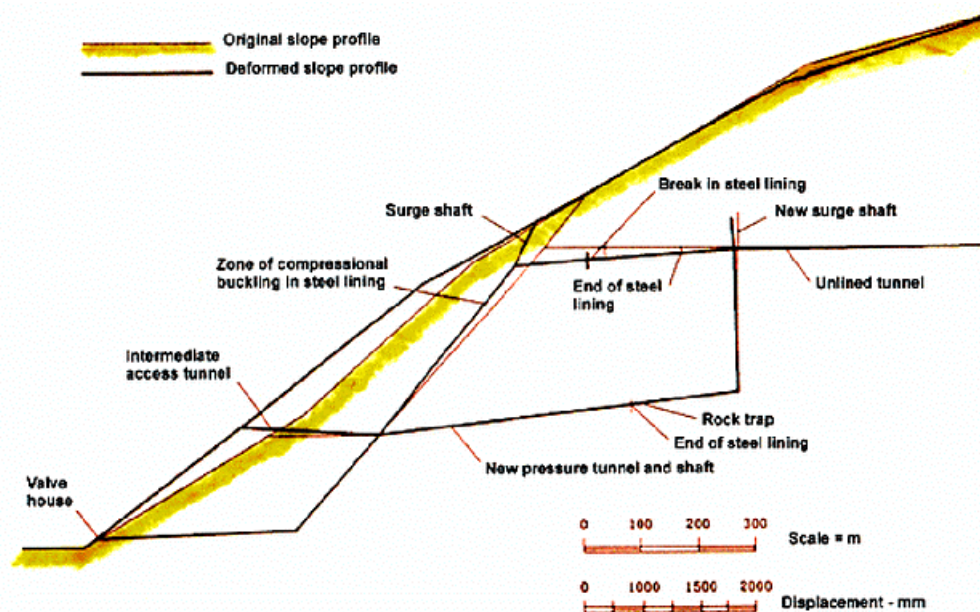
Figure 3: Cross-section through a section of the Wahleach power tunnel showing the original tunnel alignment and the location of the replacement conduit. The dashed line is the approximate location of a gradational boundary between loosened, fractured and weathered rock and more intact rock. Down-slope movement currently being monitored is well above this boundary.

Figure 3 is a section through part of the power tunnel for the Wahleach hydroelectric project in British Columbia, Canada. A break in the steel lining in this power tunnel occurred in January 1989 and it is thought this break was caused by a slow down-slope gravitational movement caused by block rotations within a near-surface zone of loosened jointed rock.

The water conduit operated without incident between the initial filling in 1952 and May 1981 when leakage was first noted from the upper access adit located near the intersection of the inclined shaft and the upper tunnel (see Figure 3). This leakage stopped when two drain pipes embedded in the concrete backfill beneath the steel lining were plugged at their upstream ends. Large holes had been eroded in these drainage pipes where they were not encased in concrete and it was concluded that this corrosion was responsible for the leakage. This conclusion appeared to be valid until 25 January, 1989 when a much larger water flow occurred.

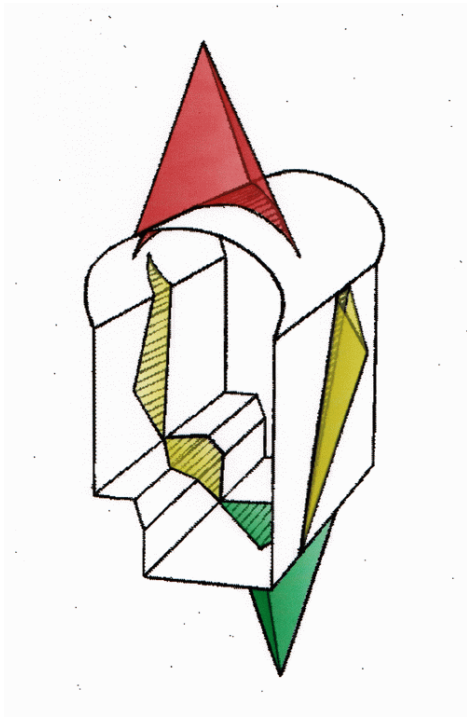
Figure 4: Perspective view of Río Grande power cavern showing potentially unstable wedges in the roof, sidewalls, bench and floor.

Early recognition of the potential instability problems, identification and visualization of the wedges which could be released and the installation of support at each stage of excavation, before the wedge bases were fully exposed, resulted in a very effective stabilisation program. Apart from a minimal amount of mesh and shotcrete applied to areas of intense jointing, no other support was used in the power cavern which has operated without any signs of instability since its completion in 1982.

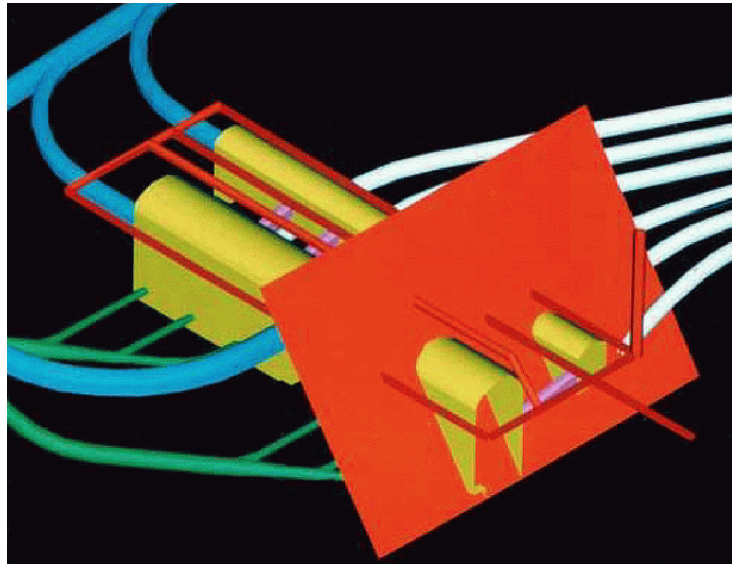
Figure 5: Orientation of the underground excavations in relation to the faults in the bedded sandstone surrounding the power cavern and transformer hall of the Mingtan Project. The red plane indicates the dip and strike of the faults.

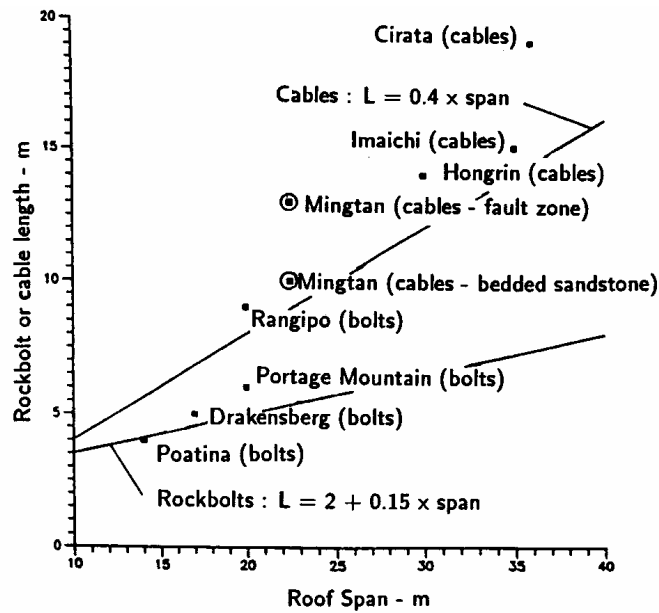
Figure 6: Lengths of rockbolts and cables used for roof support in some large caverns in weak rock. Equations defining trend lines were suggested by Barton (1989).

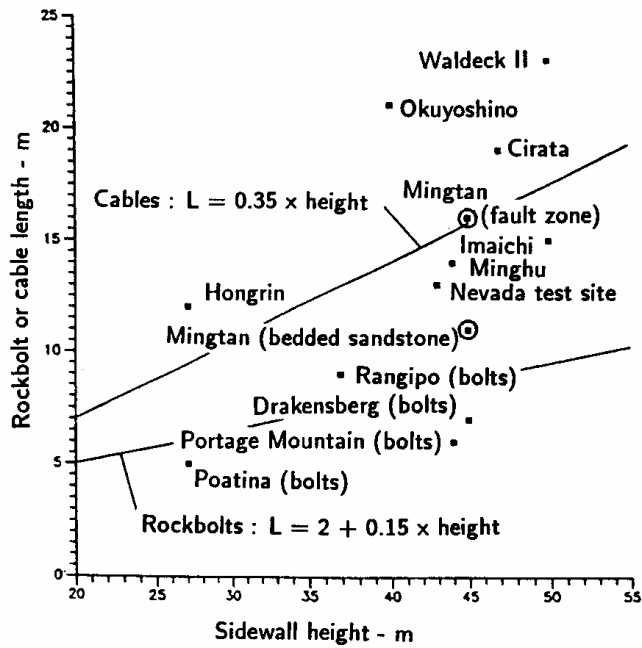
Figure 7: Lengths of rockbolts and cables used for sidewall support in some large caverns in weak rock. Equations defining trend lines were suggested by Barton (1989).

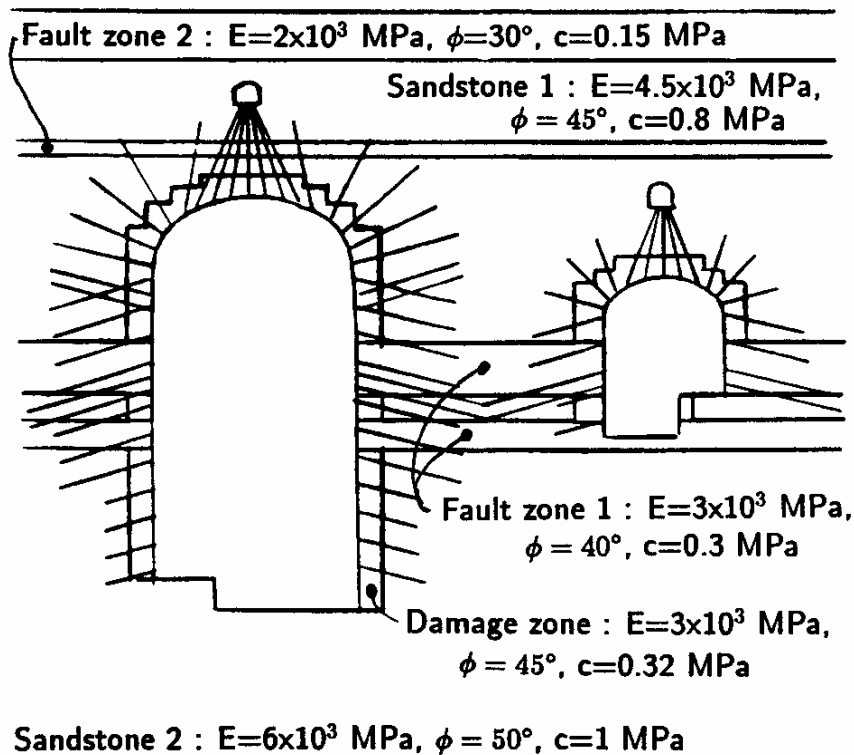
Figure 8: Layout of cables used to support the rock surrounding the power cavern and the transformer hall in the Mingtan pumped storage project. The location and properties of the rock units represent those used in the numerical analysis of failure, deformation and cable loading in a typical vertical section.

Figure 8 shows the combination of materials used in analysing one section of the cavern, assuming that the bedding faults could be represented by horizontal layers in the two-dimensional model. In order to match the measured and predicted displacements in the rock mass, it was found that a 2.5 m thick zone of softened and weakened material had to be wrapped around the excavations to account for blast damaged material (achieving good blasting results was difficult in this interbedded rock).

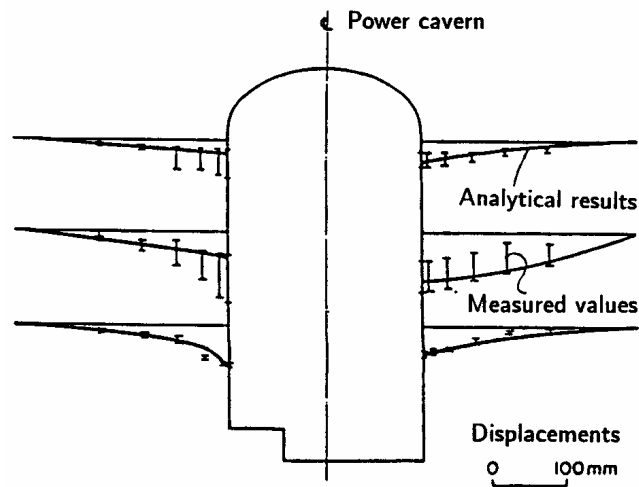
Figure 9: Comparison between calculated and measured displacements along six extensometers installed in the sidewalls of the Mingtan power cavern.

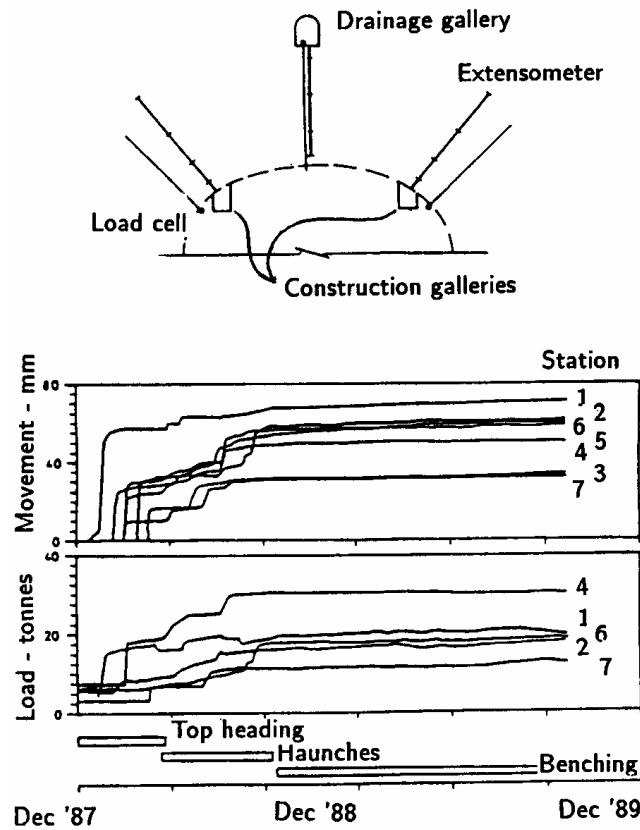
Figure 10: Surface displacements and cable loads measured at seven stations along the power cavern axis.

Rapid responses were recorded in all extensometers and load cells as the top heading passed underneath them. Further responses occurred as the haunches of the cavern arch were excavated and as the first bench was removed. As can be seen from the plots, after this rapid response to the initial excavation stages, the displacements and cable loads became stable and showed very little tendency to increase with time. The difference in the magnitudes of the displacements and cable loads at different stations can be related to the proximity of the monitoring instruments to faults in the rock above the cavern arch.

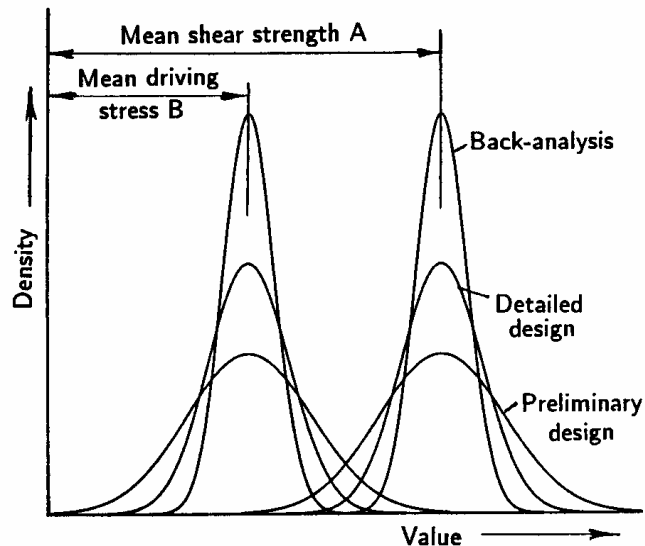
Figure 11: Hypothetical distribution curves representing the degree of uncertainty associated with information on driving stresses and shear strengths at different stages in the design of a structure such as a dam foundation.

Figure 11 illustrates a set of hypothetical distribution curves representing the degree of uncertainty associated with available information on shear strength parameters and disturbing stresses for different stages in the design of a rock or soil structure. The factor of safety is defined as A/B where A is the mean of the distribution of shear strength

Figure 11 illustrates the hypothetical distribution curves for the range of values for shear strength and driving stresses for the case of a structure in which an existing failure has been carefully back-analyzed. Depending upon the degree of care which has been taken with this back-analysis, these curves will be very tightly constrained and a low factor of safety can be used for the design of the remedial works.
