When is a design in rock engineering acceptable?

Müller Lecture

Presented by Evert Hoek, September 1991

Proceedings of the 7th International Congress on Rock Mechanics, Aachen

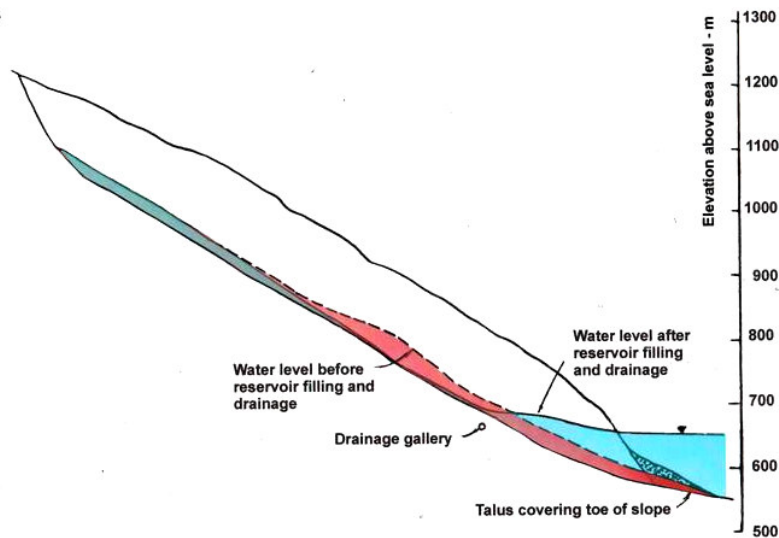
A section through Dutchman's Ridge is given in Figure 1 and this shows the water levels in the slope before reservoir filling and after reservoir filling and the construction of the drainage system. Figure 2 shows contours of reduction in water levels as a result of the installation of the drainage system which consisted of 872 m of adit and 12,000 m of drainhole drilling. Note that the drawdown area on the right hand side of the potential slide was achieved by long boreholes from the end of the drainage adit branch.

Figure 1. Section through Dutchman's Ridge showing potential slide surface and water levels before and after drainage.

Comparative studies of the stability of the slope section shown in Figure 1, based upon a factor of safety of 1.00 for the slope after reservoir filling but before implementation of the drainage system, gave a factor of safety of 1.06 for the drained slope. This 6% improvement in factor of safety may not seem very significant to the designer of small scale rock and soil slopes but it was considered acceptable in this case for a number of reasons:

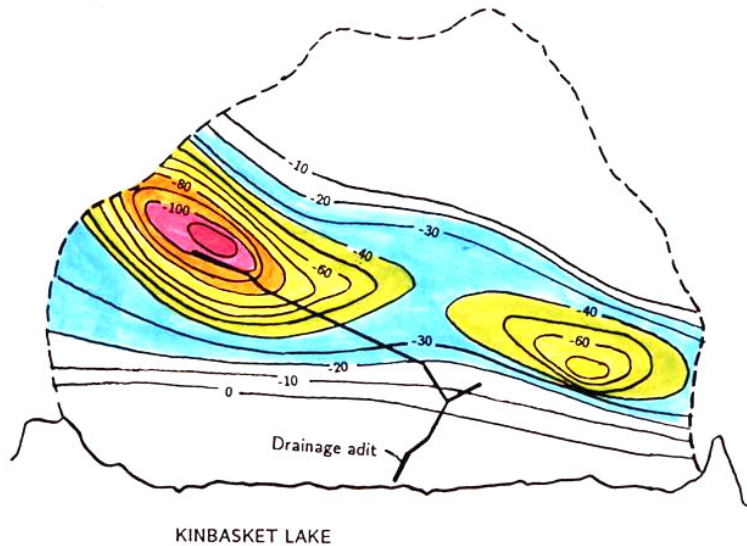
Figure 2. Contours of water level reduction (m) as a result of the implementation of drainage in Dutchman's Ridge.

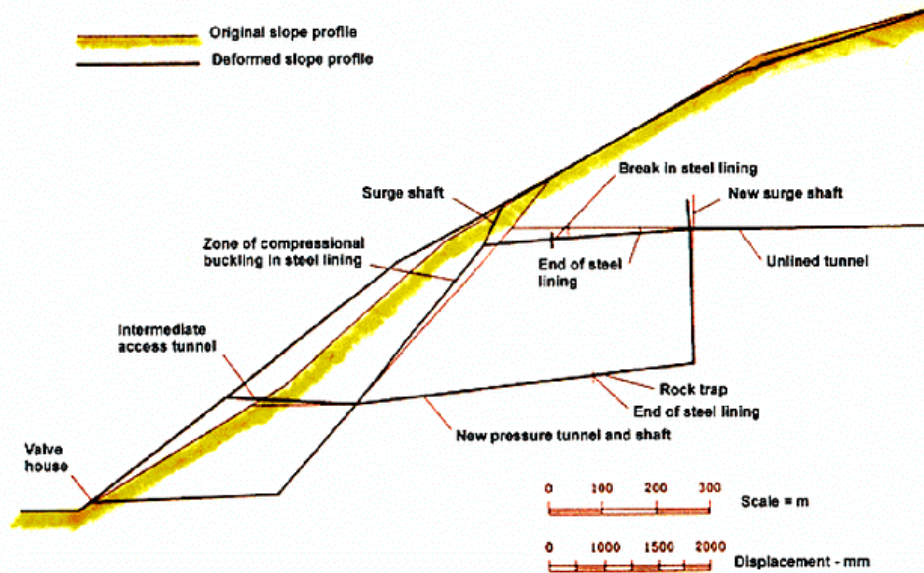
Figure 3. Cross-section through a section of the Wahleach power tunnel showing the original tunnel alignment and the location of the replacement conduit. The dashed line is the approximate location of a gradational boundary between loosened, fractured and weathered rock and more intact rock. Down slope movement currently being monitored is well above this boundary.

Figure 3 is a section through part of the power tunnel for the Wahleach hydroelectric project in British Columbia, Canada. A break in the steel lining in this power tunnel occurred in January 1989 and it is thought this break was caused by a slow down-slope gravitational movement caused by block rotations, sliding and tilting of a near surface zone of loosened jointed rock.

The water conduit operated without incident between the initial filling in 1952 and May 1981 when leakage was first noted from the upper access adit located near the intersection of the inclined shaft and the upper tunnel (see Figure 3). This leakage stopped when two drain pipes embedded in the concrete backfill beneath the steel lining were plugged at their upstream ends. Large holes had been eroded in these drainage pipes where they were not encased in concrete and it was concluded that this corrosion was responsible for the leakage. This conclusion appeared to be valid until 25 January 1989 when a much larger water flow occurred.

Investigations in the dewatered tunnel revealed a 150 mm wide circumferential tension crack in the steel lining of the upper tunnel, about 55 m from its intersection with the inclined shaft. In addition, eight compressional buckle zones were found in the upper portion of the inclined shaft. Subsequent investigations revealed that approximately 20 million cubic metres of rock are involved in down-slope creep which, during 1989-90, amounted to several centimetres per year and which appears to be ongoing. This down-slope creep appears to be related to a process of block rotation rather than to any deep seated sliding as was the case at both the Downie Slide and Dutchman's Ridge.

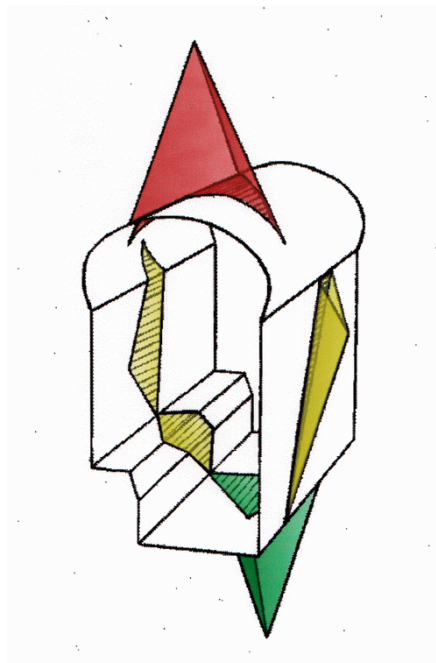
Figure 4 is a perspective view of the Río Grande power cavern showing typical wedges which can be formed in the roof, sidewalls, bench and floor by joint sets 2, 3 and 4. These figures represent the maximum possible sizes of wedges which can be formed and, during construction, the sizes of the wedges were scaled down in accordance with average joint trace lengths measured in the excavation faces.

Figure 4. Perspective view of Rio Grande power cavern showing potentially unstable wedges in the roof, sidewalk, bench and floor.

In Figure 4 it is evident that the roof and the two sidewall wedges were potentially unstable and that they needed to be stabilized. This stabilization was achieved by the placement of tensioned and grouted rockbolts which were installed at each stage of the cavern excavation. Decisions on the number, length and capacity of the rockbolts were made by on-site geotechnical staff using limit equilibrium calculations based upon the volume of the wedges defined by the measured trace lengths. For those wedges which involved sliding on one plane or along the line of intersection of two planes, rockbolts were installed across these planes to bring the sliding factor of safety of the wedge up to 1.5. For wedges which were free to fall from the roof, a factor of safety of 2 was used. This factor was calculated as the ratio of the total capacity of the bolts to the weight of the wedge and was intended to account for uncertainties associated with the bolt installation.

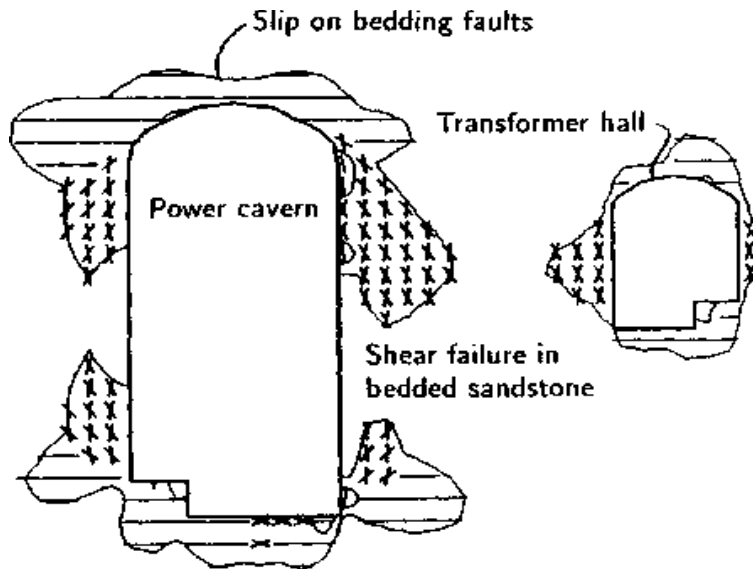
The results of a simple analysis of the zones of overstress in the rock mass surrounding the Mingtan underground excavations are presented in Figure 5. The crosses in this figure are directions along which shear failure is predicted in the bedded sandstone while the horizontal lines indicate slip along the faults (assuming $c' = 0.15$ MPa, $\phi' = 30^\circ$). While it is not claimed that this analysis adequately represents the complex process of failure initiation and propagation on the inclined faults and in the jointed rock mass surrounding the caverns, it does give sufficient information to suggest that the cavern can be stabilized by means of a pattern of long grouted cables supplemented by a layer of shotcrete on the excavation surface.

Figure 5. Predicted zones of over-stress along faults and in bedded sandstone surrounding the power cavern and transformer hall of the Mingtan Project.

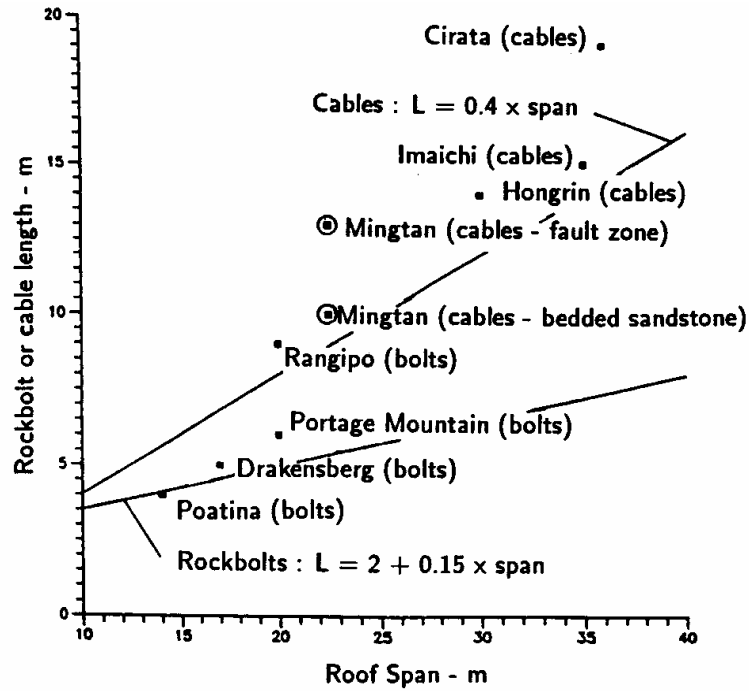
Figure 6. Lengths of rockbolts and cables used for roof support in some large caverns in weak rock. Equations defining trend lines were suggested by Barton (1989).

The design of the reinforcing cables was based upon experience and precedent practice. Figures 6 and 7 give the lengths of rockbolts and cables in the roof and sidewalls of some typical large powerhouse caverns in weak rock masses. Plotted on the same graphs are empirical relationships suggested by Barton (1989) for bolt and cable lengths for underground powerhouses.

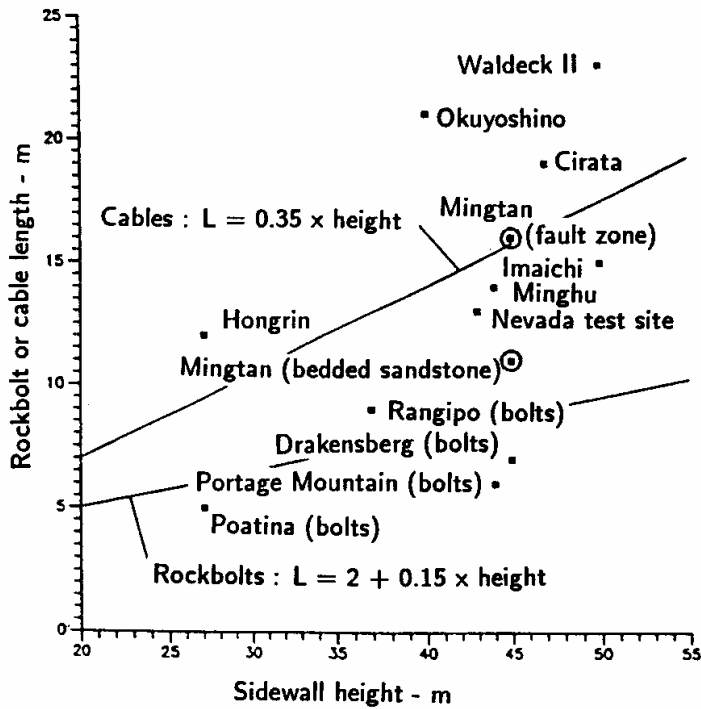
Figure 7. Lengths of rockbolts and cables used for sidewall support in some large caverns in weak rock. Equations defining trend lines were suggested by Barton (1989).

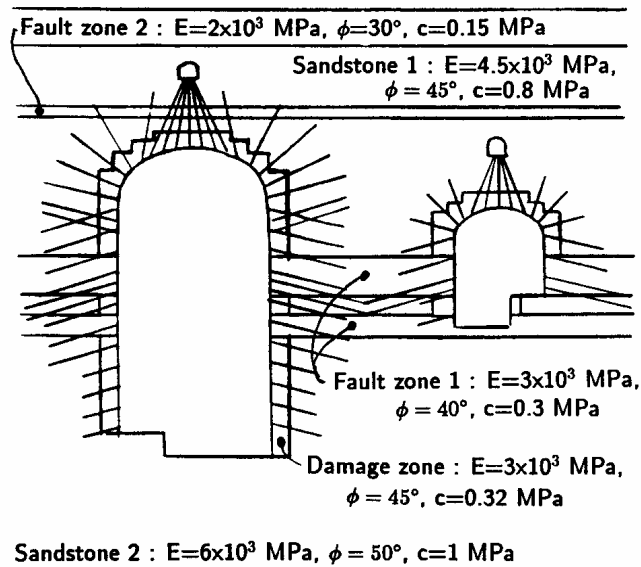
Figure 8 shows the combination of materials used in analyzing one section of the cavern, assuming that the bedding faults could be represented by horizontal layers in the two-dimensional model. In order to match the measured and predicted displacements in the rock mass, it was found that a 2.5 m thick zone of softened and weakened material had to be wrapped around the excavations to account for blast damaged material (achieving good blasting results was difficult in this interbedded rock).

Figure 8. Layout of cables used to support the rock surrounding the power cavern and the transformer hall in the Mingtan pumped storage project. The location and properties of the rock units represent those used in the numerical analysis of failure, deformation and cable loading in a typical vertical section.

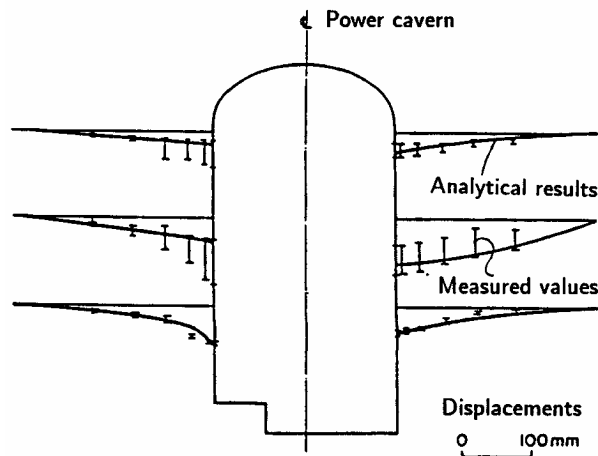
Figure 9. Comparison between calculated and measured displacements along six extensometers installed in the sidewalls of the Mingtan power cavern.

In Figure 9, the predicted and measured displacements along six extensometers installed in the power cavern sidewalls are compared. The overall agreement is considered to be acceptable. Maximum sidewall displacements were of the order of 100 mm at the mid-height of the upstream wall, adjacent to one of the major faults. Elsewhere, displacements were of the order to 25 to 46 mm.

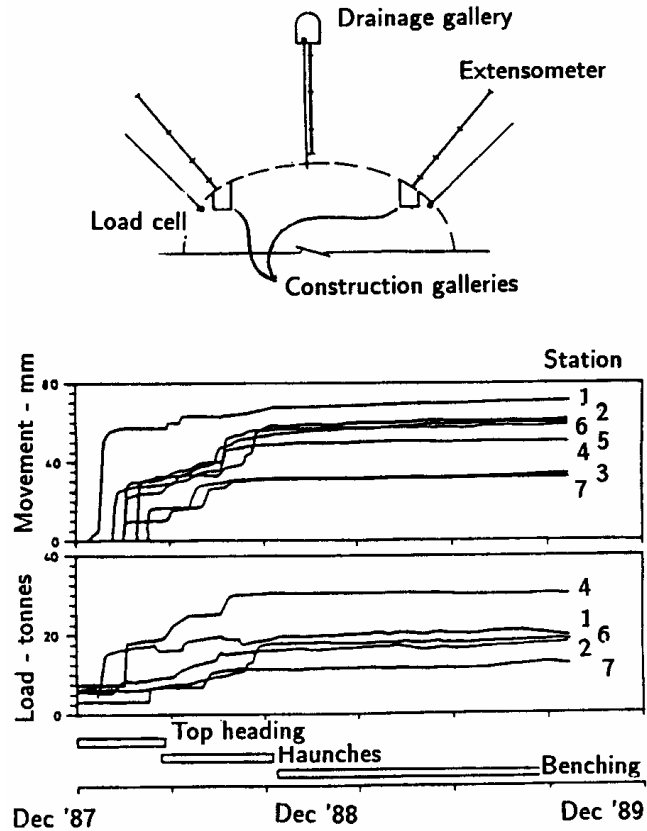
Figure 10. Surface displacements and cable loads measured at seven stations along the power cavern axis.

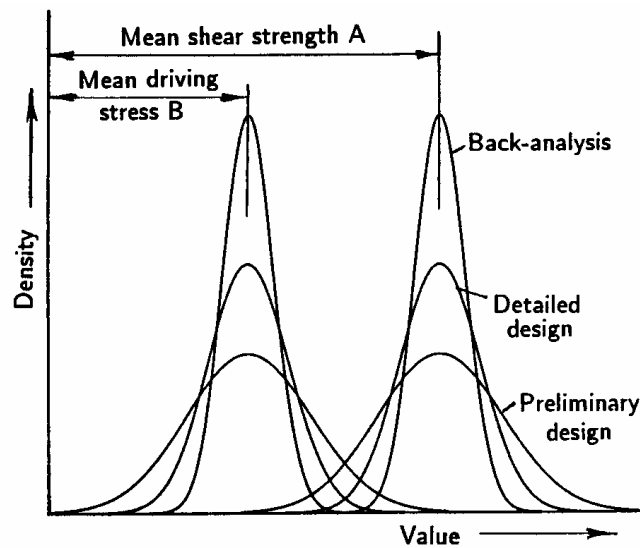
Figure 11 illustrates the hypothetical distribution curves for the range of values for shear strength and driving stresses for the case of a structure in which an existing failure has been carefully back-analyzed. Depending upon the degree of care which has been taken with this back-analysis, these curves will be very tightly constrained and a low factor of safety can be used for the design of the remedial works.

Figure 11. Hypothetical distribution curves representing the degree of uncertainty associated with information on driving stresses and shear strengths at different stages in the design of a structure such as a dam foundation.
