# A slope stability problem in Hong Kong

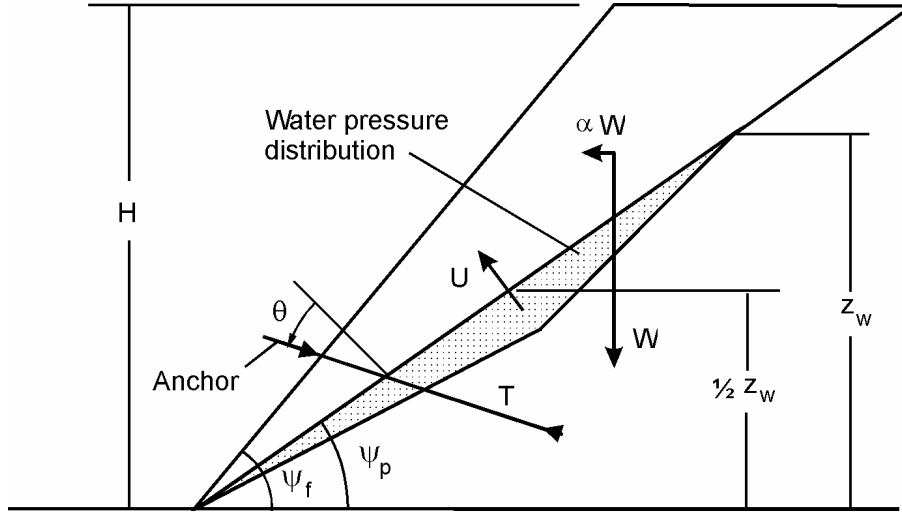
Figure 6: Factor of Safety calculation for a slope with no tension crack.

response of the slope to a range of possible conditions. The two models are defined in Figure 6 and Figure 7.

The traditional method of incorporating the acceleration induced by earthquakes or large blasts in slope stability analyses is to add an outward force  $\alpha W$  to the forces acting on the slope (see Figure 6 and Figure 7), where  $\alpha$  is the acceleration as a proportion of  $g$ , the acceleration due to gravity. This 'pseudo-static' form of analysis is known to be very conservative but, in the case of the Sau Mau Ping slope, this conservatism was not considered to be out of place.

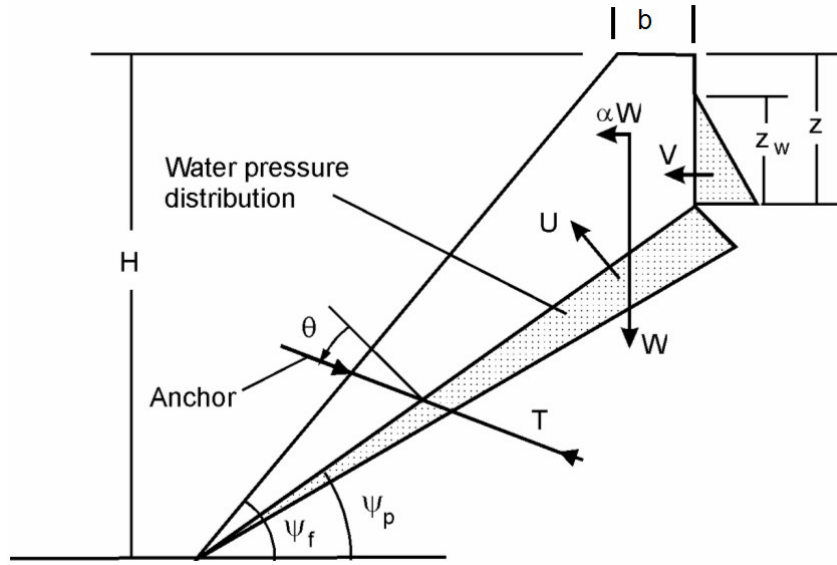
Figure 7: Factor of Safety calculation for a slope with a water-filled tension crack.

In Figure 7 the depth z of the tension crack is calculated by equation 6. This equation is obtained by minimising equation 5 with respect to the tension crack depth z (Hoek and Bray, 1974). This minimisation is carried out for a dry slope and the accuracy of equation 6 decreases as the water depth in the tension crack increases. However, for the purposes of this analysis, the estimate given by equation 6 is considered acceptable.

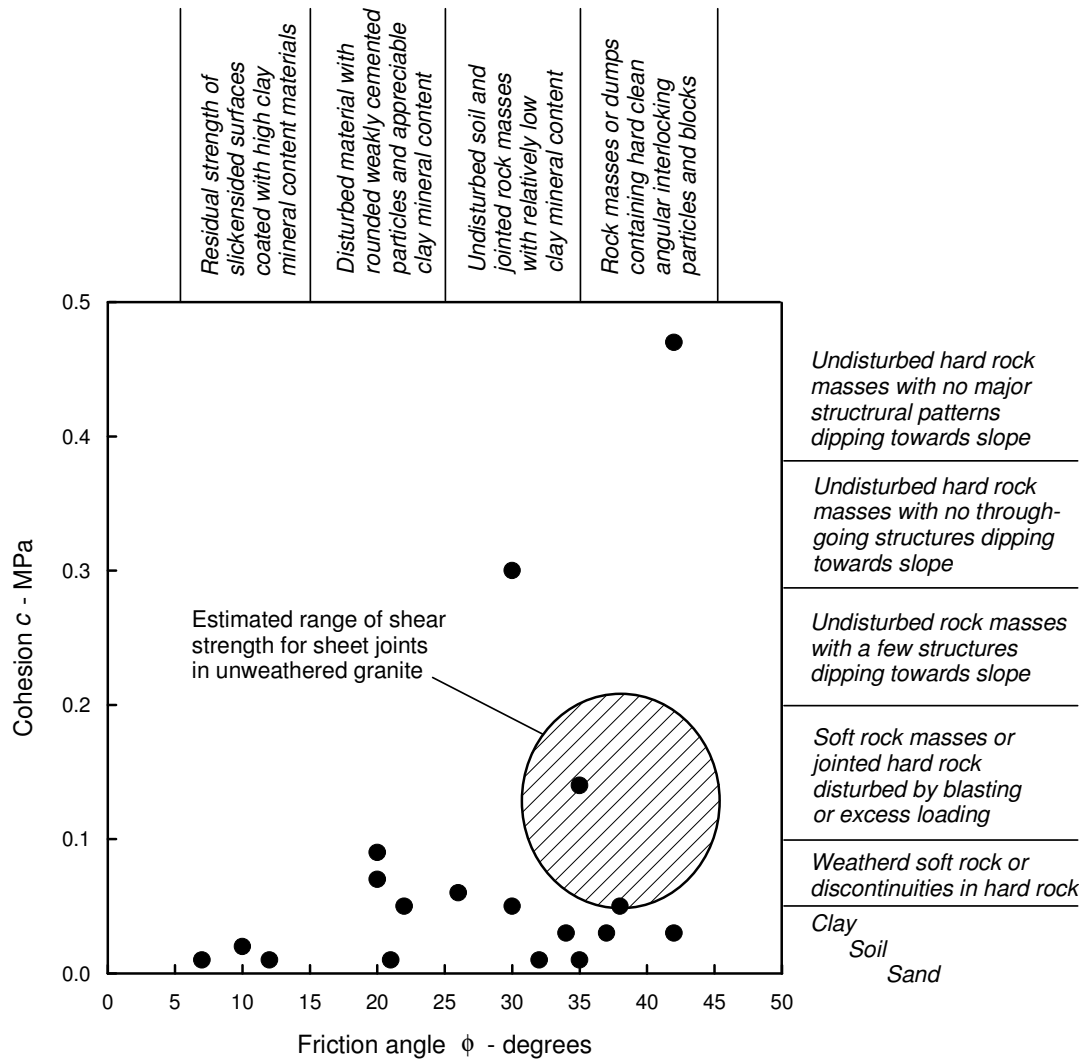
Figure 8: Relationship between friction angles and cohesive strengths mobilised at failure of slopes in various materials. The plotted points were obtained from published information from the back analysis of slope failures. (After Hoek and Bray 1974).

Hoek and Bray (1974) published a plot, reproduced in Figure 8, of cohesive strengths and friction angles for rocks and soils, based upon the results of published back analysis of slope failures. Superimposed on this plot is an elliptical zone which encompasses the estimated range of shear strength for sheet joints in unweathered granite. In choosing this range it was considered that the friction angle  $\phi$  probably ranges from  $30^\circ$  for very smooth planar surfaces to  $45^\circ$  for rough or partly cemented surfaces. The cohesive strength  $c$  is more difficult to estimate and the range of 0.05 to 0.2 MPa was chosen on the basis of the results of back-analyses of slope failures, plotted in Figure 8.
